STUDY REPORT

SR 240 (2011)

Preliminary BRANZ 2010 House Condition Survey Report – Second Edition

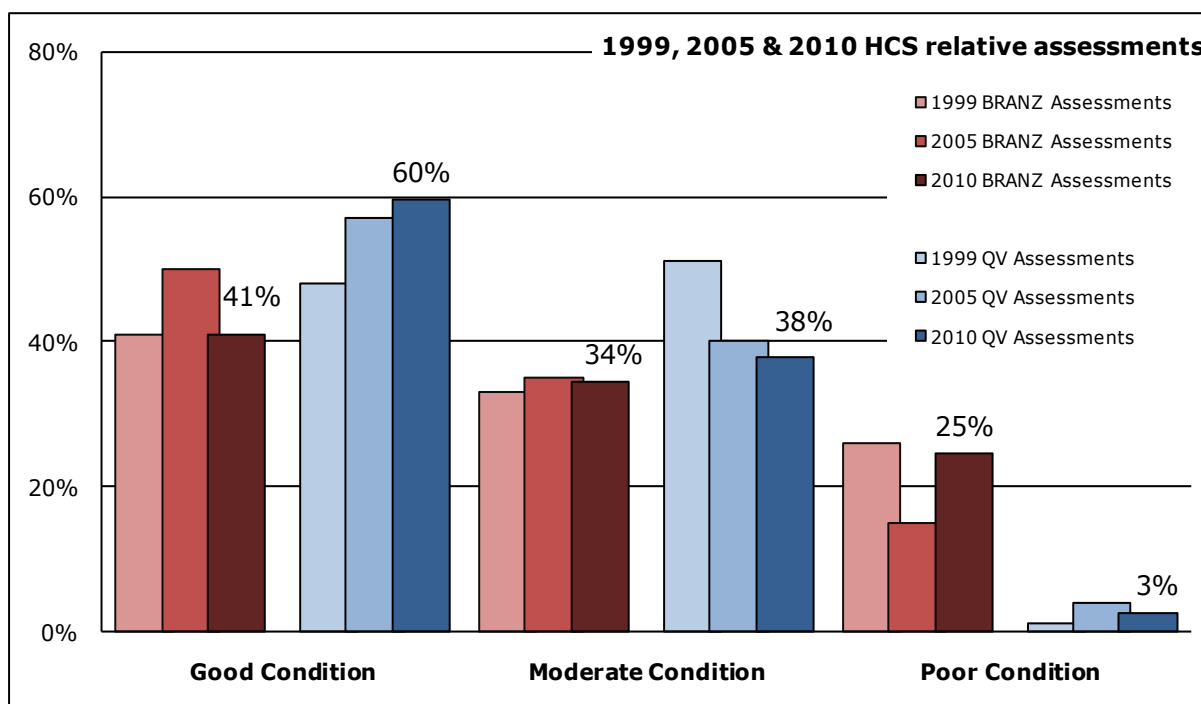
Figure 3: Assessed overall condition

Figure 3 displays the differences between the surveyors' assessments and QV's assessments from 1999 to 2010, compiled into the three condition categories. Over the years, BRANZ's surveyors have been consistently less complimentary about the condition of homes than QV.

As shown, the BRANZ surveyors considered that just over 40% of the surveyed houses were well maintained (in good or excellent condition), as was found in 1999. This is a marked decrease from around 50% in 2005. Although it could be that the overall condition of New Zealand houses has deteriorated over the five year period it is likely to be influenced by the shift to a national sample including rentals.

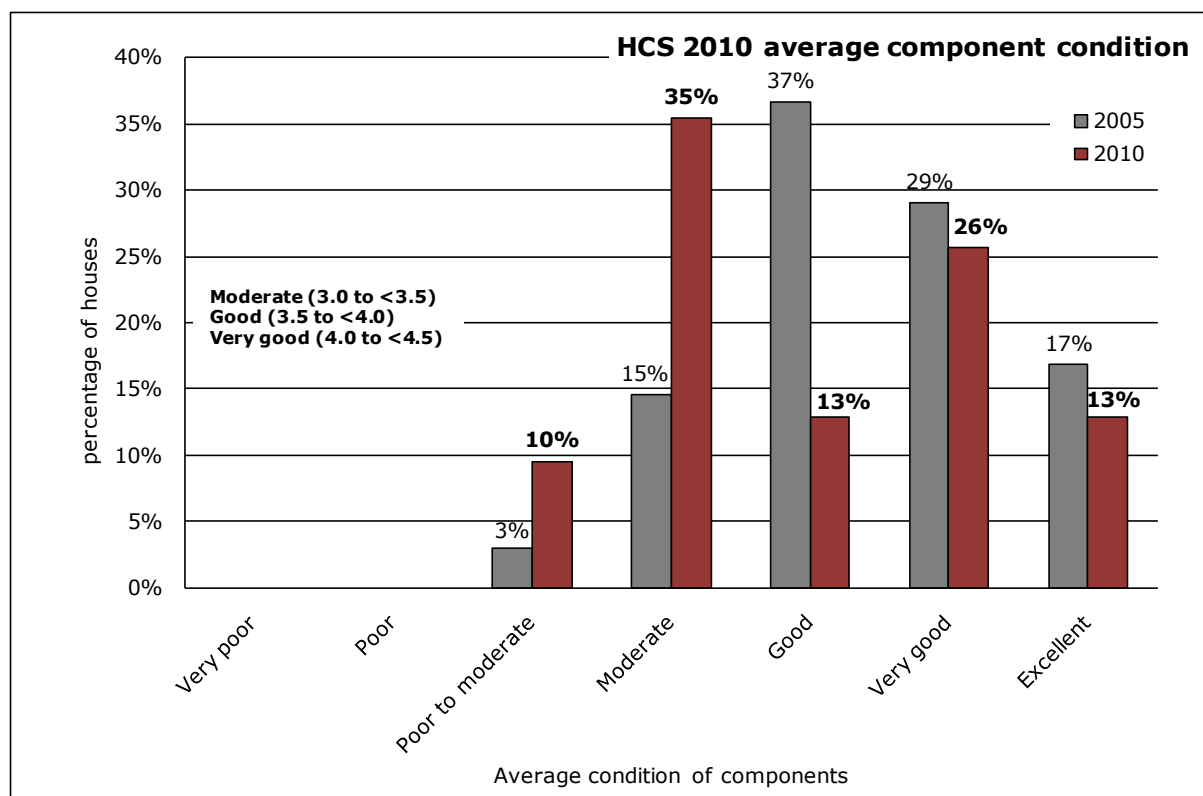
Figure 4: Average component condition – 2010 and 2005

In 2010, around half of all of the houses in the sample had average component ratings of 'good', 'very good' or 'excellent', with 10% in 'poor to moderate' condition, as shown in Figure 4. This is a marked reduction in the number of houses with components in 'good' or better than average condition, which was over 80% in 2005, with only 3% in 'poor' to 'moderate' condition.

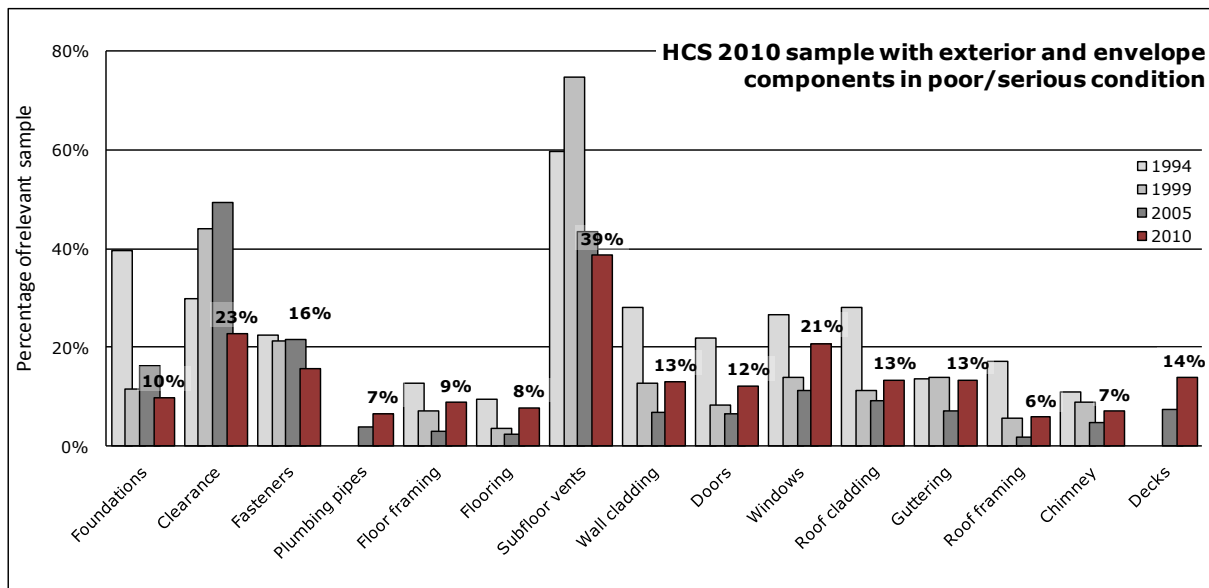
Figure 5: Envelope component condition ratings

Figure 5 shows similar areas with higher percentages of certain components in poor/serious condition. There was an overall reduction in the percentages of poor/serious condition components in most cases but there are some areas where the poor/serious condition category rose including the percentage of decks from around 7% in 2005 to 14% in 2010. Other changes observed between the surveys include:

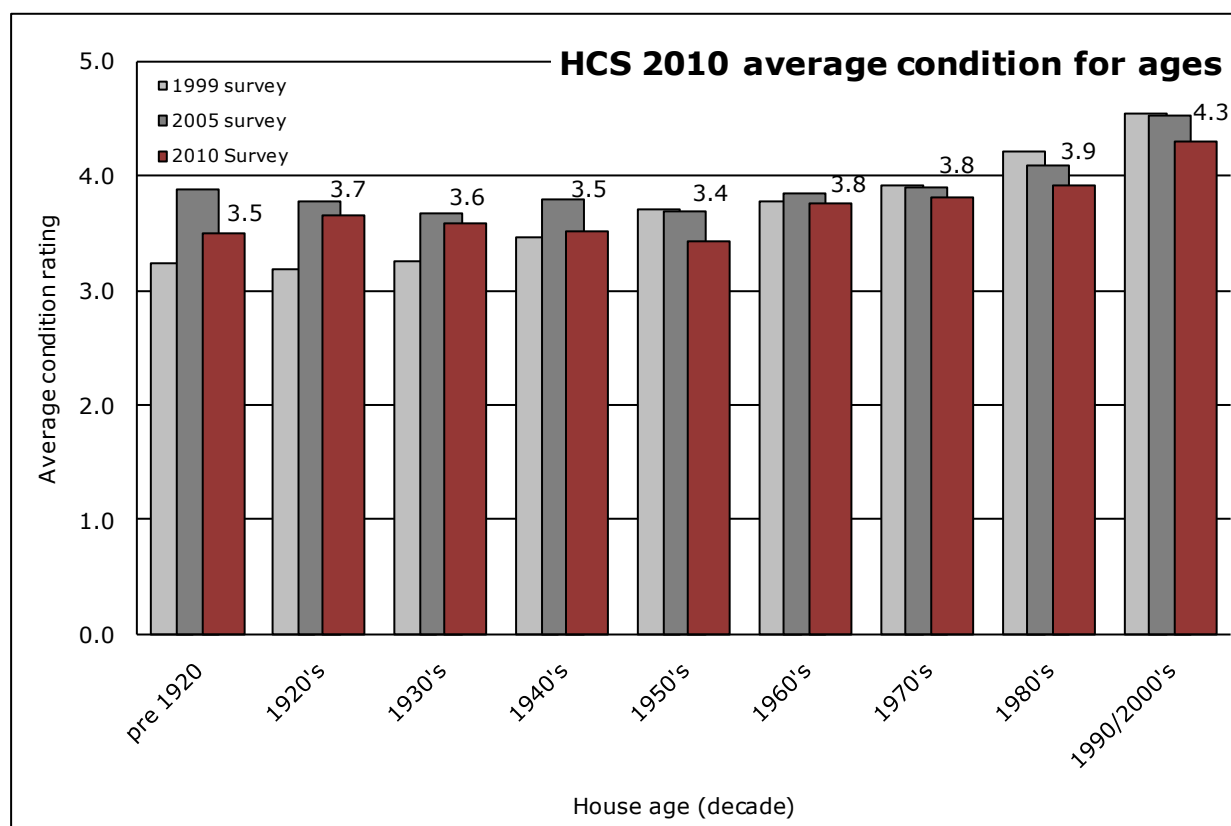
Figure 6: Average conditions by age groups

Figure 6 shows the relationship of average component condition to the age of the house. The lowest average condition was in houses built in the 1950s (3.4), although this was by a very small margin with both the 1940s decade and the pre-1920 group average having a score of 3.5. As would be anticipated the newer homes (those 1990s onwards) have the highest average component condition score of 4.3.

Figure 6 shows the average condition rating which was derived for all components of the building envelope segregated by decade of construction.

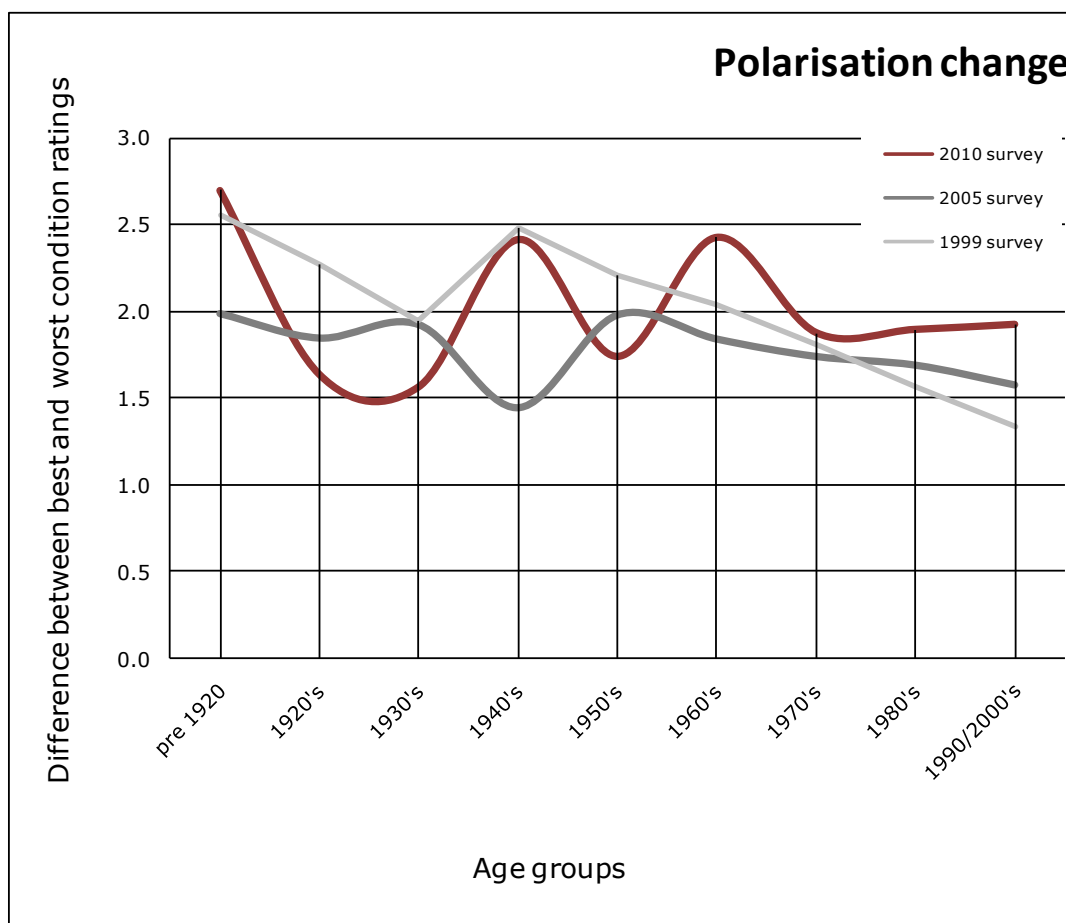
Figure 7: Polarisation of condition with age

The 2010 analysis explored this further, and we can now compare results with 1999 and 2005 as shown in Figure 7. As shown in this survey, the houses show a difference in condition rating between the worst and the best houses of around 1.8 for houses built in the 1990s and 2000s. This difference increases to almost 3 for the oldest houses.

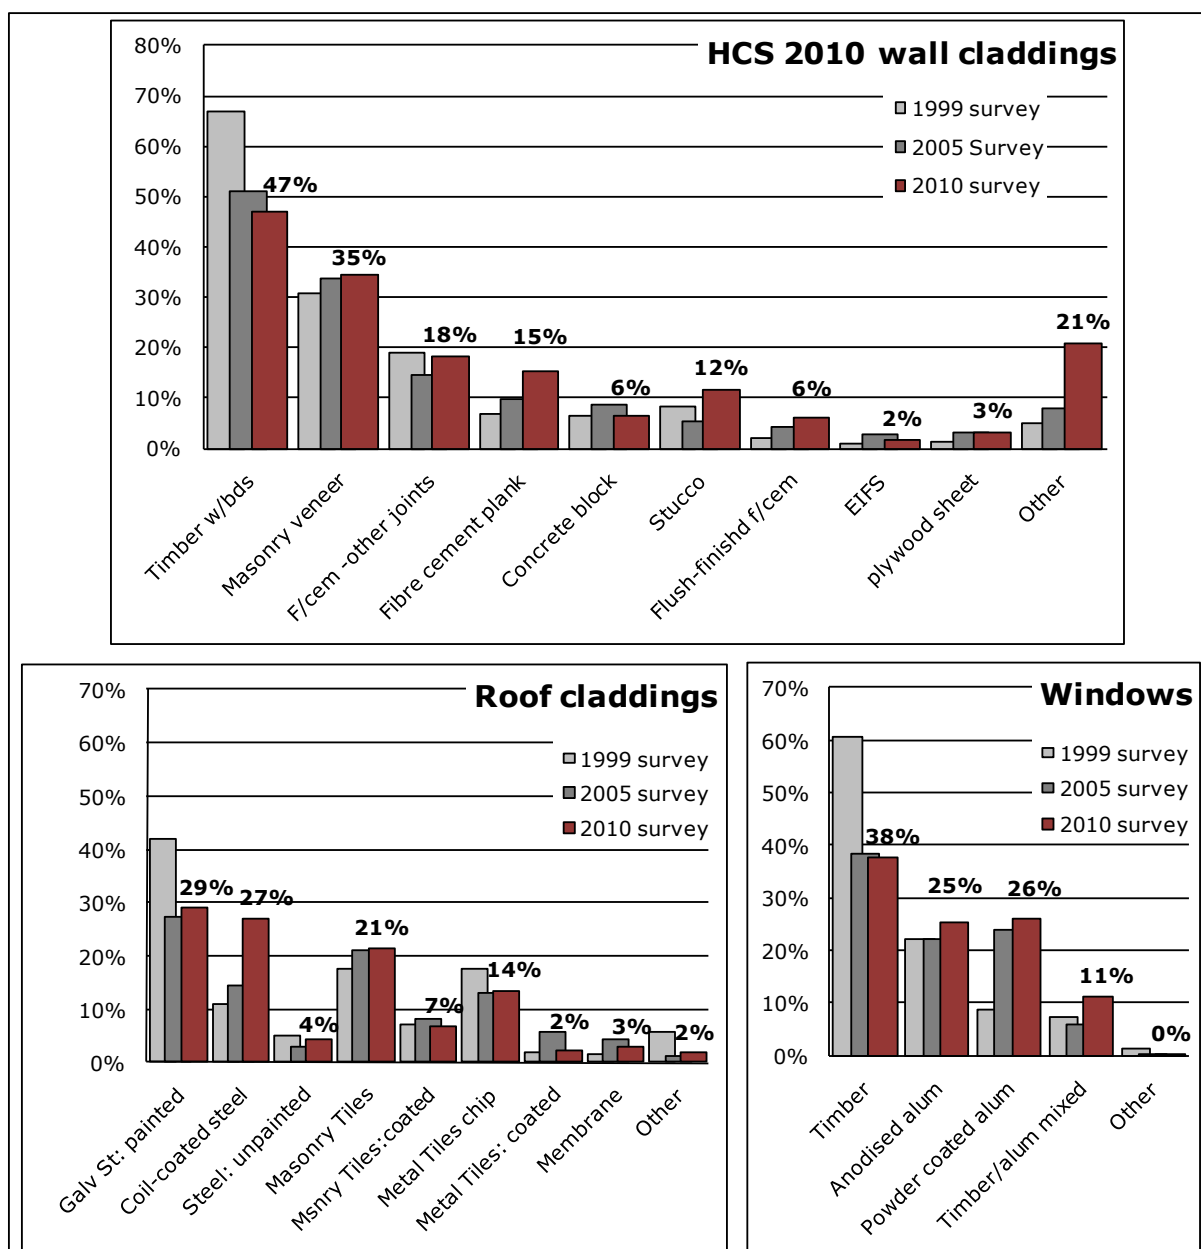
Figure 8: Building materials from sample

Figure 8 shows the most common wall cladding remains timber weatherboards, followed by masonry (i.e. brick) veneer. Timber weatherboards cover more traditional types such as bevel-backed or shiplap weatherboard through to more modern cedar. While timber weatherboards are still the most common cladding, use has continued to decrease, from being present on almost 70% of the houses in the 1999 survey to just less than half in 2010.

Materials used for walls, roofs and windows and their proportions in 2010, 2005 and 1999 are shown in Figure 8. Note that each graph does not necessarily add up to 100%, as many homes have a mixture of wall or roof claddings or window systems, either by design or due to additions or renovations.

As seen in Figure 8, just over half of the sample houses had either galvanised or coil-coated profiled metal roofs (the same as in 2005 and 1999). Over half of these were painted galvanised roofs. The proportion of coil-coated steel roofs increased nearly doubled between 2005 and 2010, while the proportion of painted and unpainted galvanised steel roofs stayed much the same.

Figure 8 shows that aluminium windows (either powder-coated or anodised) are now the most common type of window. Nearly one-quarter of the sample had both aluminium and timber window frames, reflecting renovations and the replacement of timber windows at the end of their useful lives. A higher number of houses in the sample were built after the introduction of aluminium windows in this survey, also contributing to the increase.

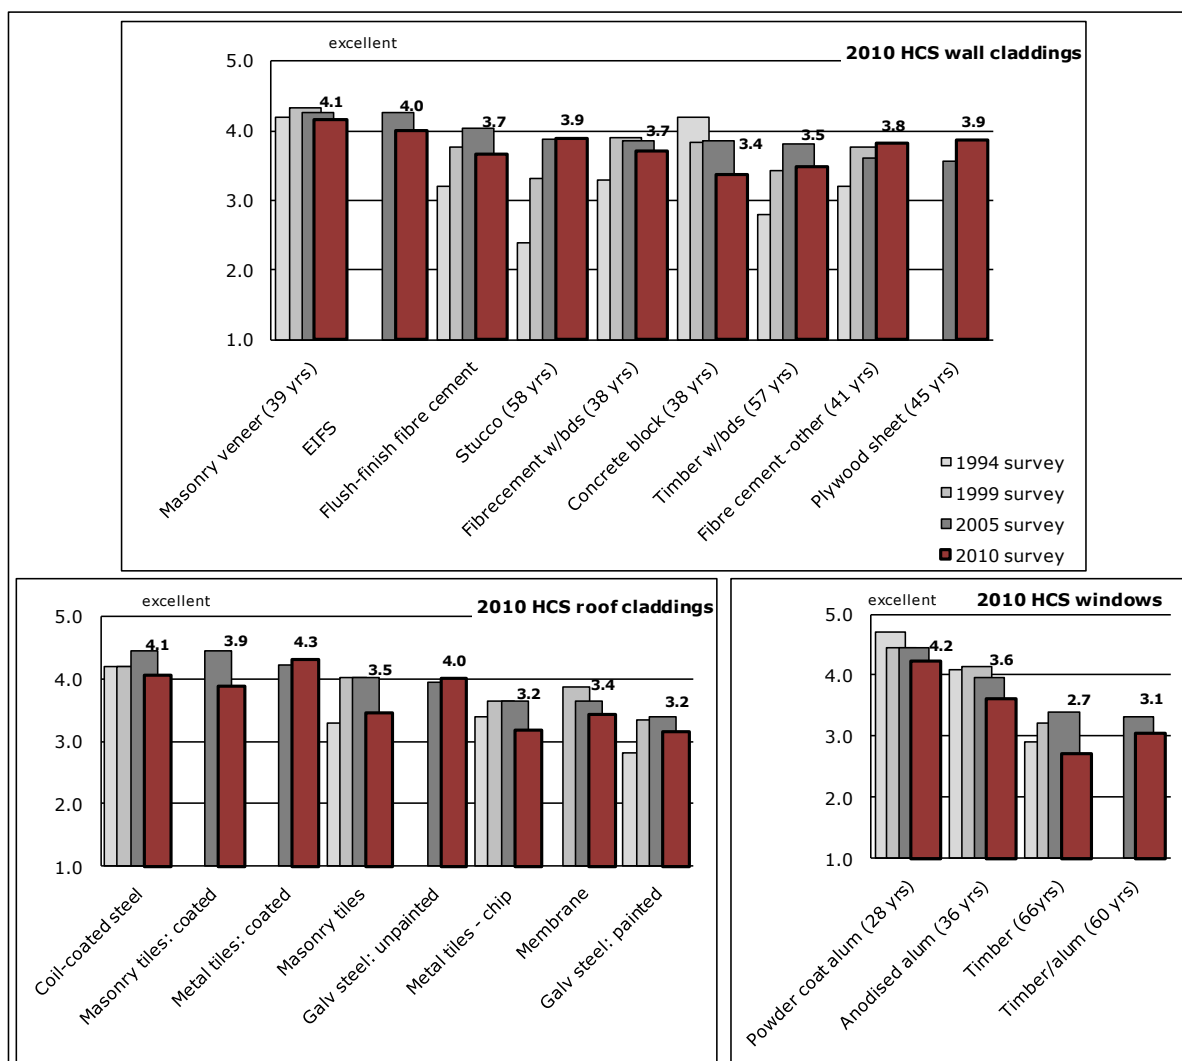
Figure 9: Condition of external materials

The average condition of all of the more common materials identified by the inspectors has been calculated, and this is shown in Figure 9 together with the equivalent figures for the 2005, 1999 and 1994 surveys.

The average ages of houses using the different types of wall cladding and windows are shown in brackets where the sample of houses with the material was sufficient, so that average condition ratings can be assessed against the likely age of the materials. Roofs are not considered, as their replacement generally has less to do with the age of the house and more with the conditions they are exposed to.

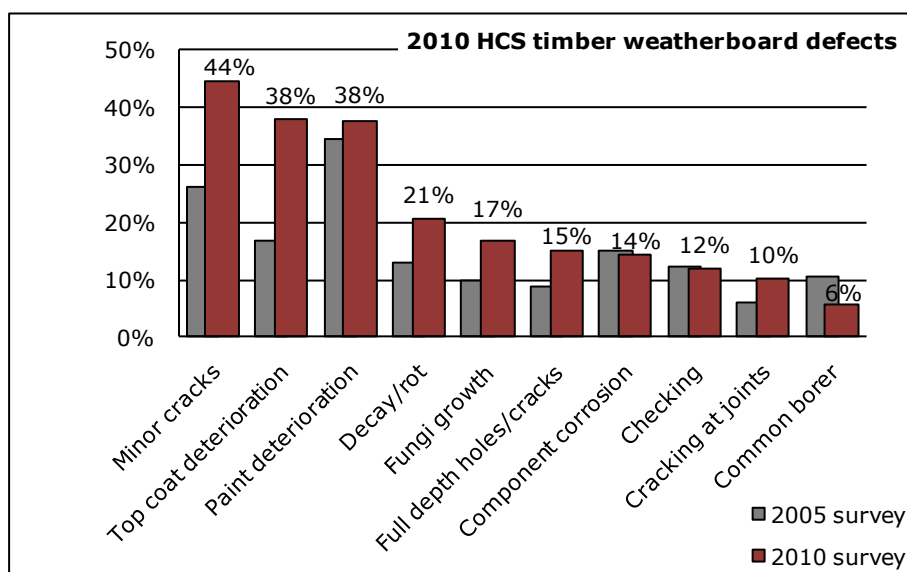
Figure 10: Defects in timber weatherboards

Timber weatherboards were present on approximately half of the sample. The most common defects found in timber weatherboards are shown in Figure 10, and Figure 11 shows the frequency that these defects occur, indicating the level of severity.

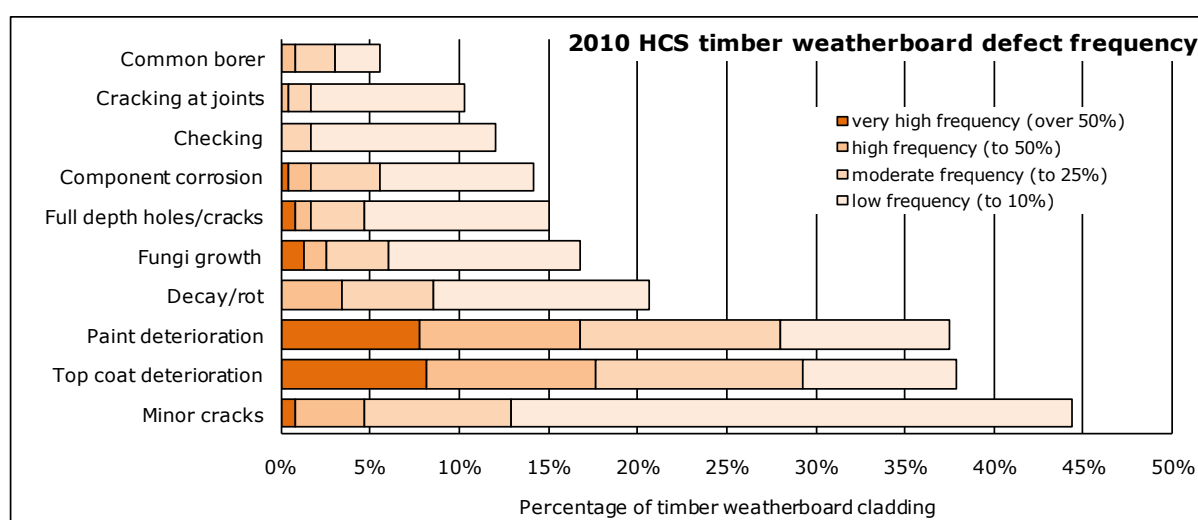
The most common defects with the highest frequency are paint deterioration (through more than just the top-coat) and top-coat deterioration. Minor cracks were the most frequently noted defect, although they tended to be of a lower frequency, as shown in Figure 11. Decay and rot was predominantly of a low frequency, as was fungi growth and the corrosion of components.

Figure 11: Defect frequency in timber weatherboards

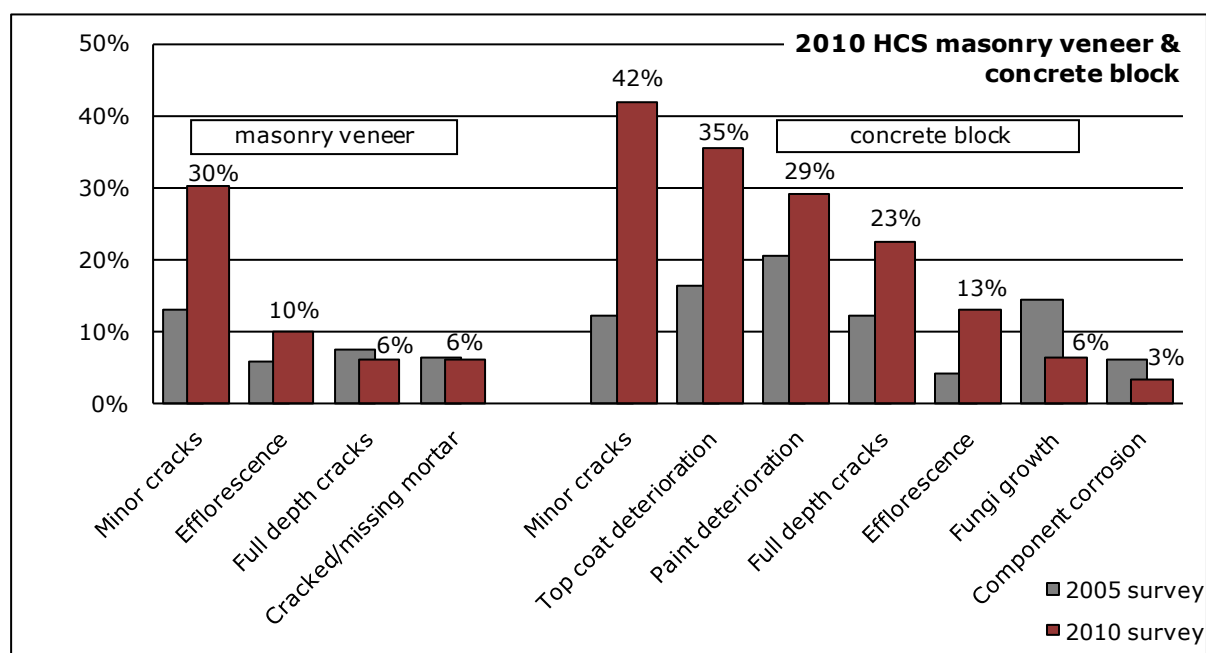
Figure 12: Defects in masonry veneer and concrete block

Around one-third of the houses had at least some masonry veneer cladding, and around 6% had concrete block wall(s). The most common defects for masonry veneer and concrete block are displayed in Figure 12.

The most common defects for both masonry veneer and concrete block walls in this survey were minor cracks. Top-coat and paint deterioration were common cosmetic defects for concrete block walls. Twenty-three percent of the sample of concrete block wall samples exhibited full depth cracks.

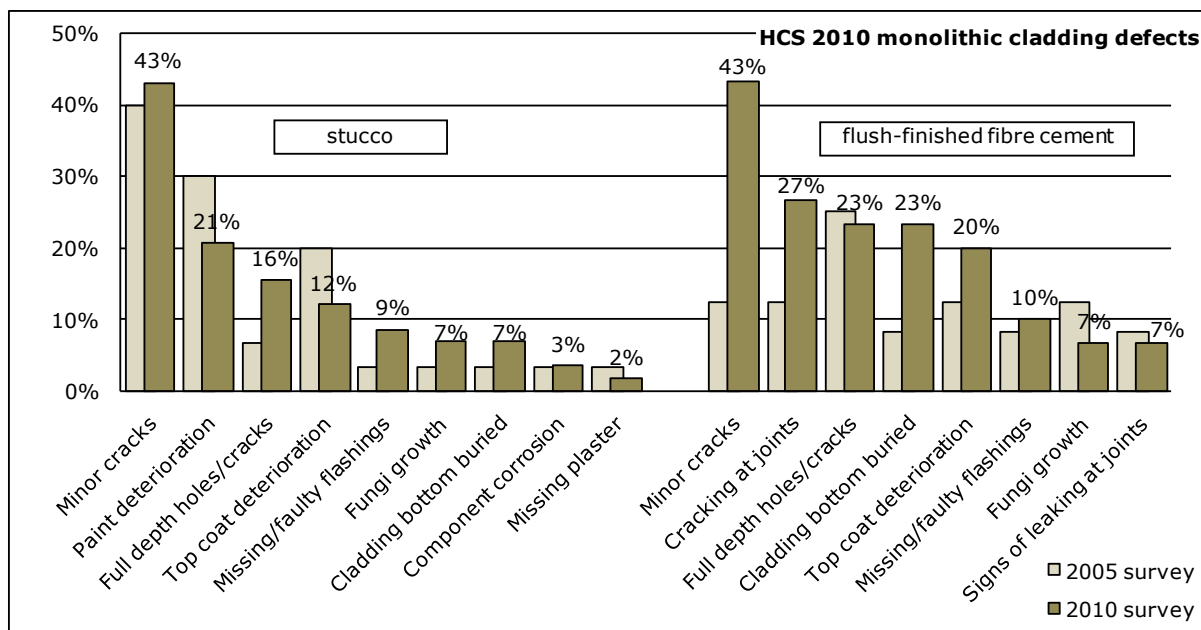
Figure 13: Defects in monolithic claddings

The most common defect for stucco cladding was minor cracks at 43%, followed by paint deterioration on 21%.

Minor cracks were also the main defect in flush-finished fibre-cement, also at 43%, and this was followed by cracking at joints with 27%. These defects may be related to age, and maintenance practices.

Figure 13 shows the defects found in the 2010 *House Condition Survey* sample. The results from the monolithic cladding defects should be treated with caution, as the *House Condition Survey* assesses the condition of monolithic cladding from the external appearance. This establishes that the true condition of the system requires destructive testing in order to check for issues on the rear face of the cladding. The surface appearance may conceal underlying issues.

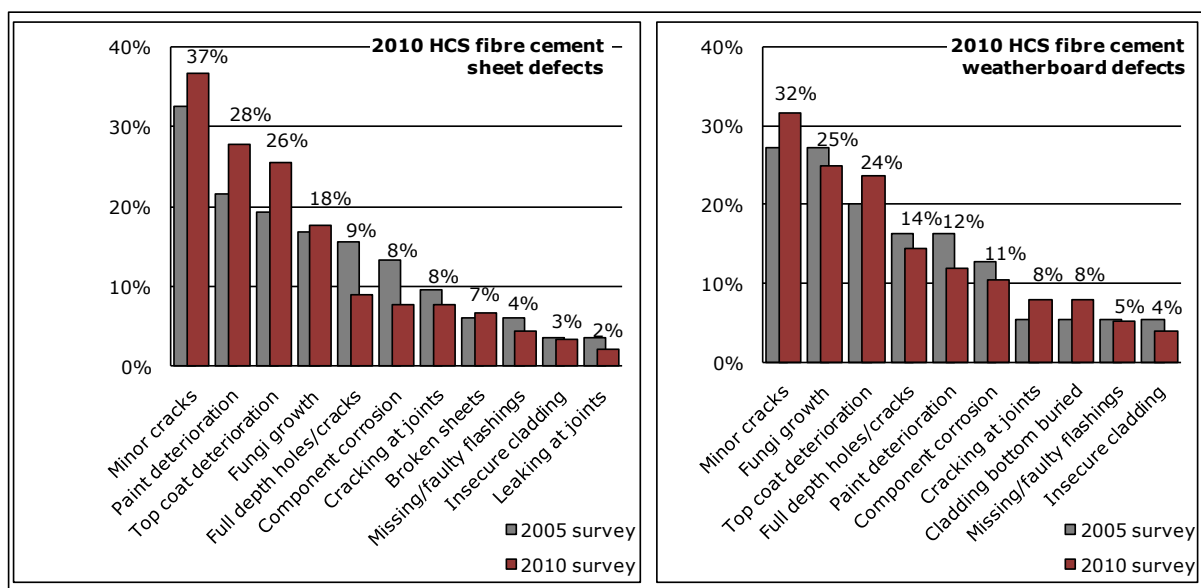
Figure 14: Fibre-cement wall cladding defects – sheet and weatherboard

The most common defect in both fibre-cement sheets and weatherboards was paint deterioration. Interestingly, more fibre-cement weatherboards had fungi growth compared to

The defects in other fibre-cement claddings are shown in Figure 14.

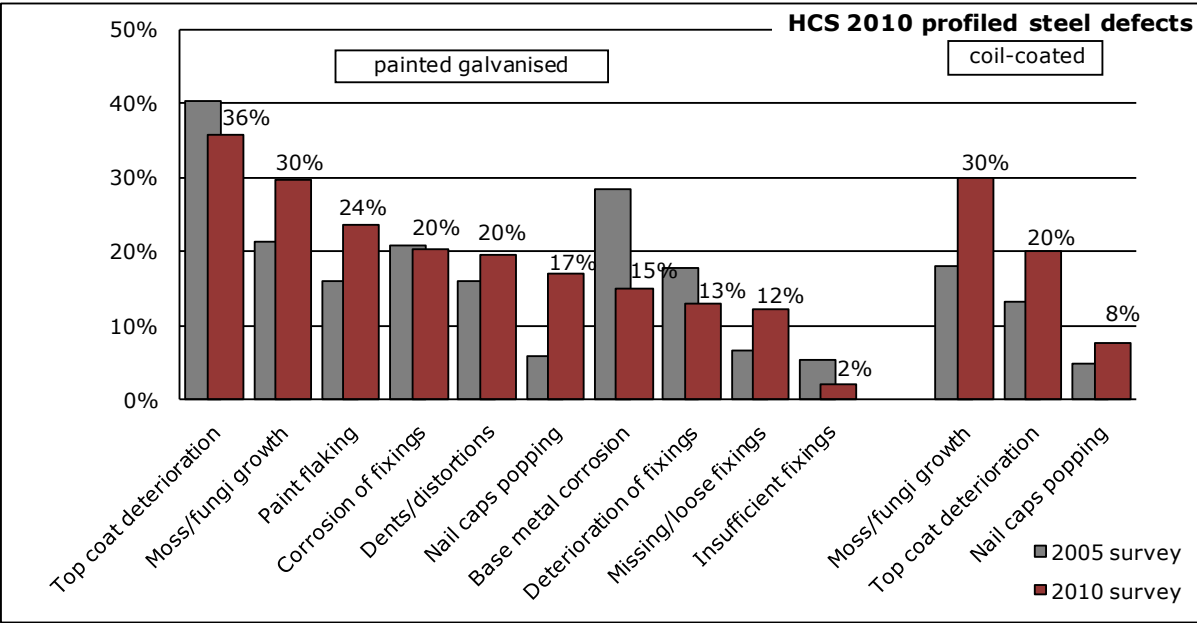
Figure 15: Defects in profiled steel roofing

The most common defects for painted galvanised steel roofing were top-coat deterioration (36%), moss/fungi growth (30%) and paint flaking (24%). With coil-coated steel being a more modern material than galvanised steel, the roofs using it tend to be newer, and the most common defect is moss/fungi growth (30%). The frequency of defects in profiled steel roof cladding is shown in Figure 16.

As shown in Figure 8, profiled steel roofing (both galvanised and coil-coated) is the most common roof cladding, being present on over half of the houses in the sample. The most frequently observed defects are shown in Figure 15.

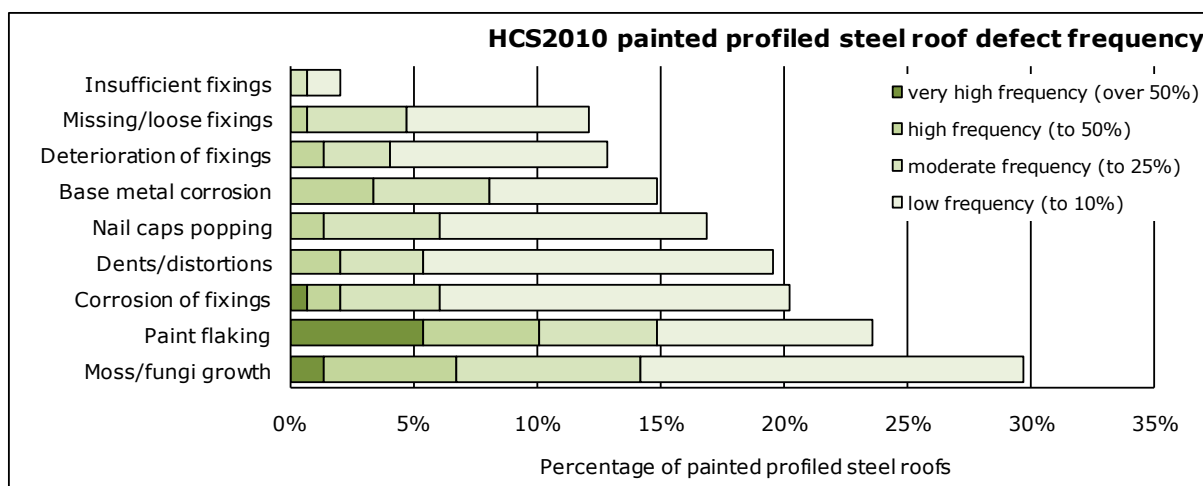
Figure 16: Defect frequency in painted galvanised steel

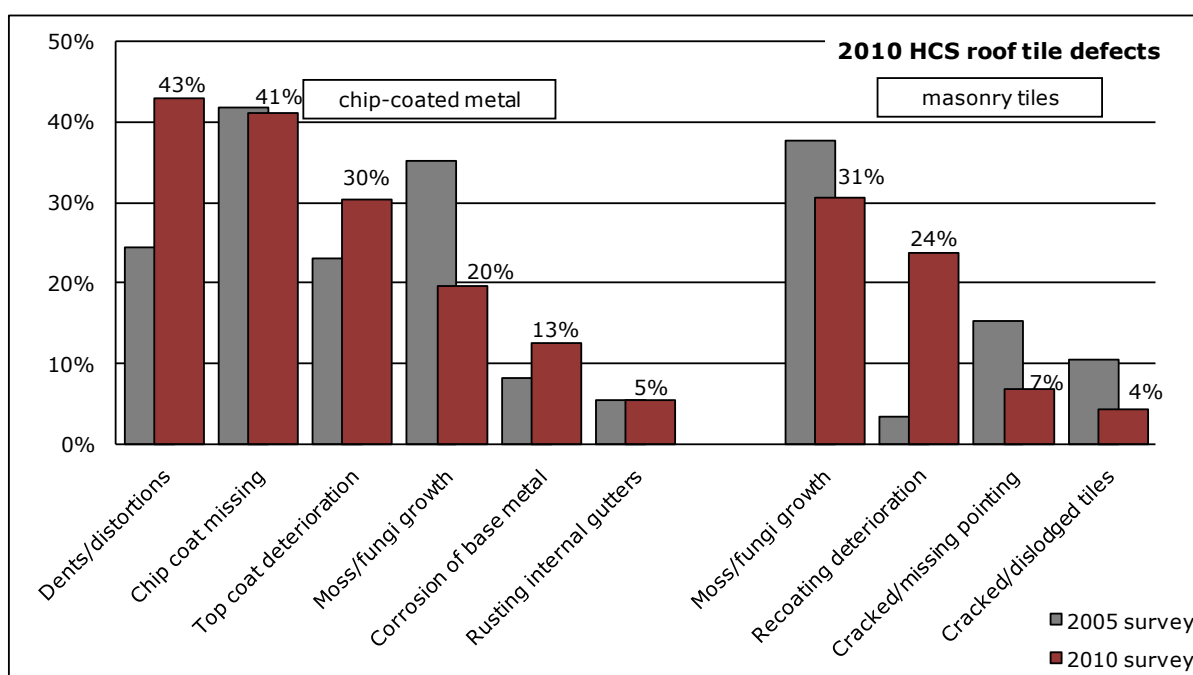
Figure 17: Defects in roof tiles

As shown, the most common defects in chip-coated metal tiles are the erosion of the chip coating, dents and top-coat deterioration. The percentage of chip-coated metal roofs with dents has increased to 43%, which may be related to thinner gauges of steel used on newer tiles, or perhaps increased foot traffic due to maintenance, including moss and fungi removal, or recoating. The reduction in the percentage of chip-coated metal tiles roofs affected by moss and/or fungi suggests this is a strong possibility.

The next most common roof cladding types were masonry tiles (28%) and metal roof tiles (16%). Figure 17 shows the most common defects found in tiles.

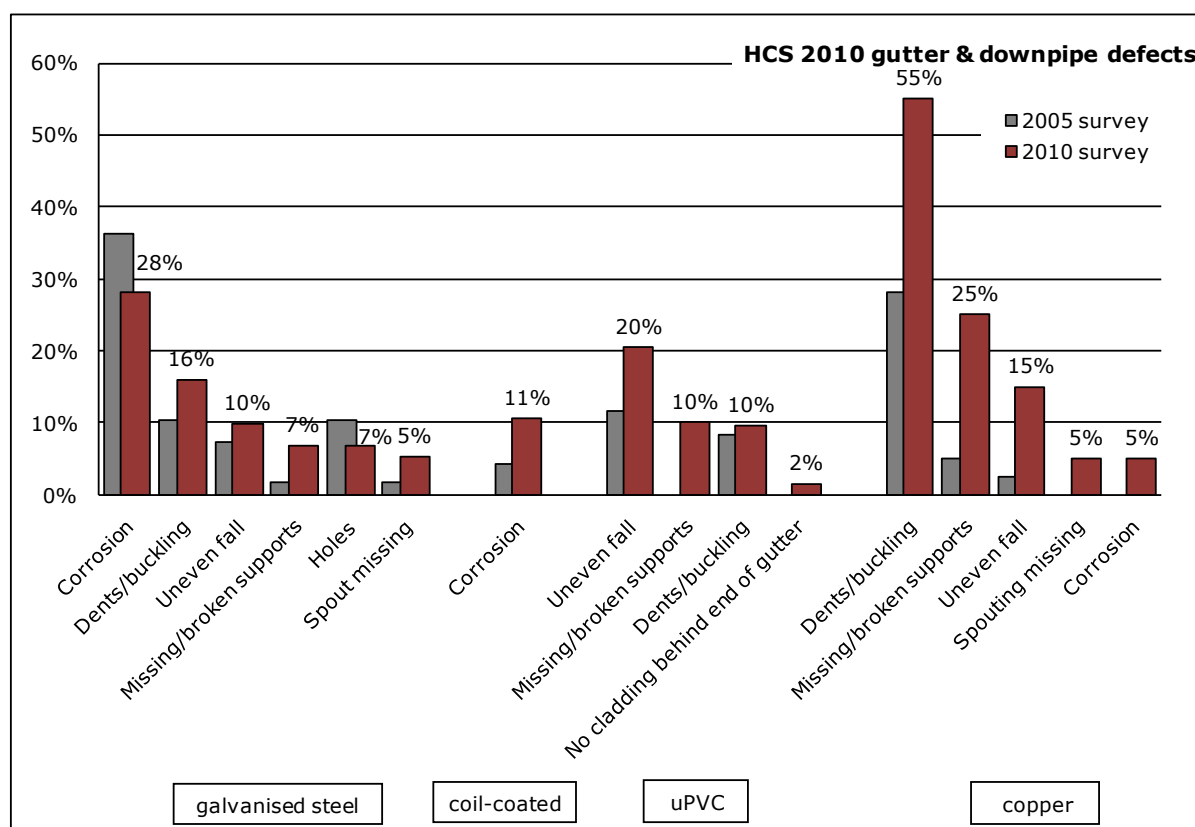
The most common defects found in guttering and downpipes in the survey can be seen in Figure 18. The most common defects in galvanised steel gutters and downpipes were corrosion and denting/buckling, while the most common defect in coil-coated guttering and downpipes was corrosion.

Figure 18: Defects in gutters and downpipes

The most common defect found in uPVC guttering and downpipes was uneven fall in the guttering, affecting 20%. The next most common defects were missing/broken supports (potentially related to uneven fall), and dents/buckling, both at 10%.

The most common copper guttering and downpipe defect was denting/buckling, affecting 55% of the houses with this type of guttering to varying degrees, followed by missing or broken supports at 25%. Both defects may well be associated with age – copper guttering has become more popular since the mid 1990s, and with age comes the need for maintenance – which often includes ladders leaning on guttering. As copper is expensive, it tends to be a thin gauge and is highly malleable - dents and distortions will occur more readily than in coil-coated steel, whereas plastic deflects, or at worst breaks.

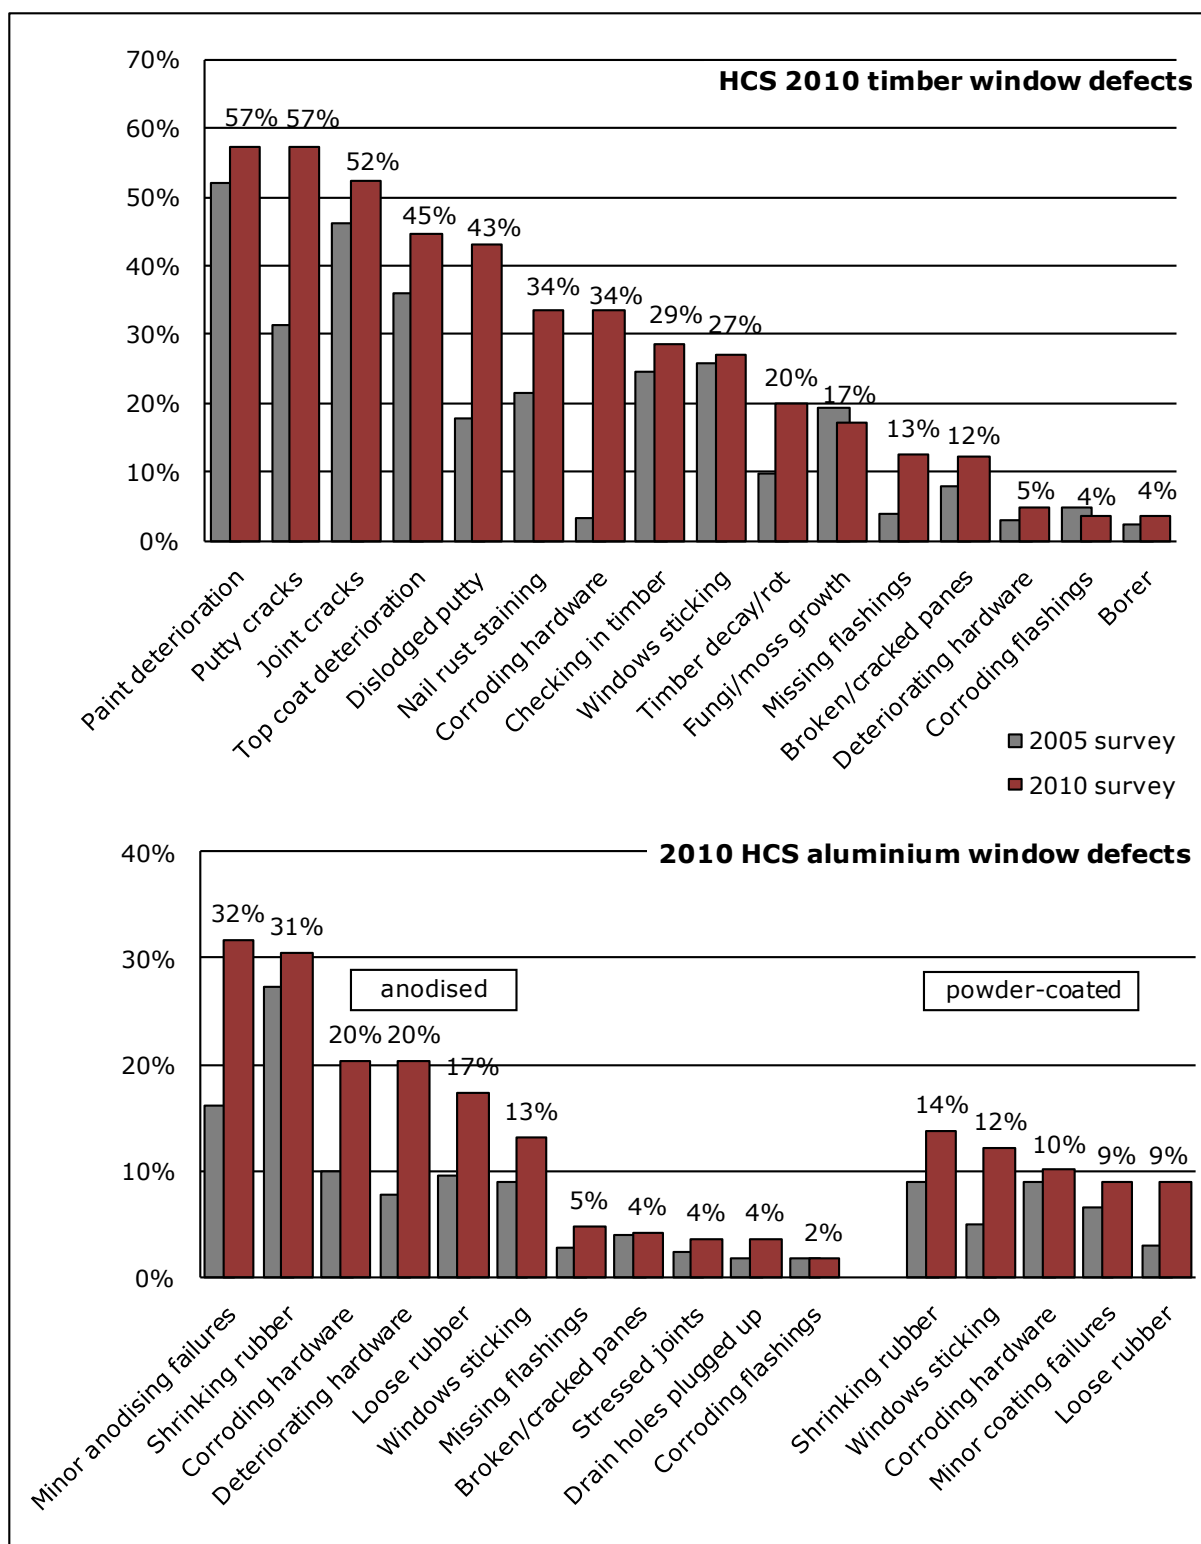
Figure 20: Defects in windows

Figure 20 shows the most common defect for timber windows was the deterioration of paintwork related to the lack of regular/well-executed paint jobs. There was less than 10% of the sample with windows affected by borer, or corroding or missing flashings.

The most frequent defects for each window type are shown in Figure 20.

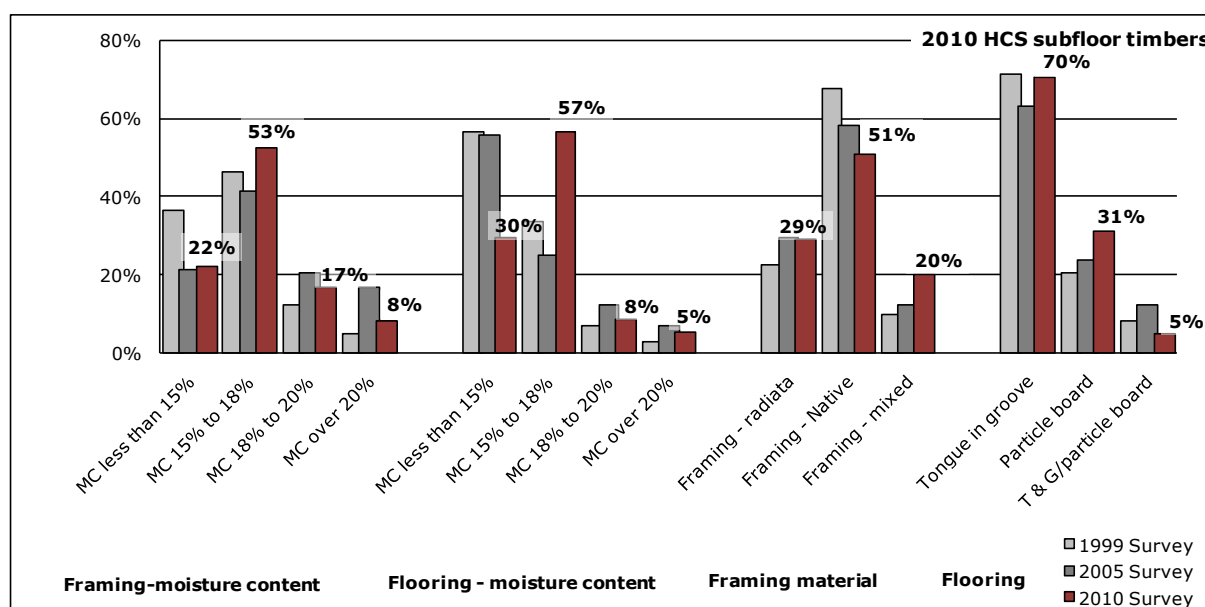
Figure 21: Characteristics of subfloor timbers

As shown, characteristics are similar to those found in the 1999 and 2005 surveys. There is a lower proportion of framing and flooring with moisture content over 18% than observed in 2005, although it is still slightly higher than what was found in 1999. The amount of timber flooring is less than in previous surveys, in part due to the shift in the sample including a higher proportion of concrete slab floors. There was a large increase in the amount of radiata timber, a more modern framing material, and a decrease in native timber framing. This is likely to be due to the increased number of houses in the sample built with modern building materials, and modern alterations to older homes.

In common with the 1999 survey, inspectors identified many recurring problems related to subfloor spaces, so these are considered as a separate group of components. Figure 21 gives the characteristics associated with subfloor timbers, and compares these to the 1999 and 2005 surveys.

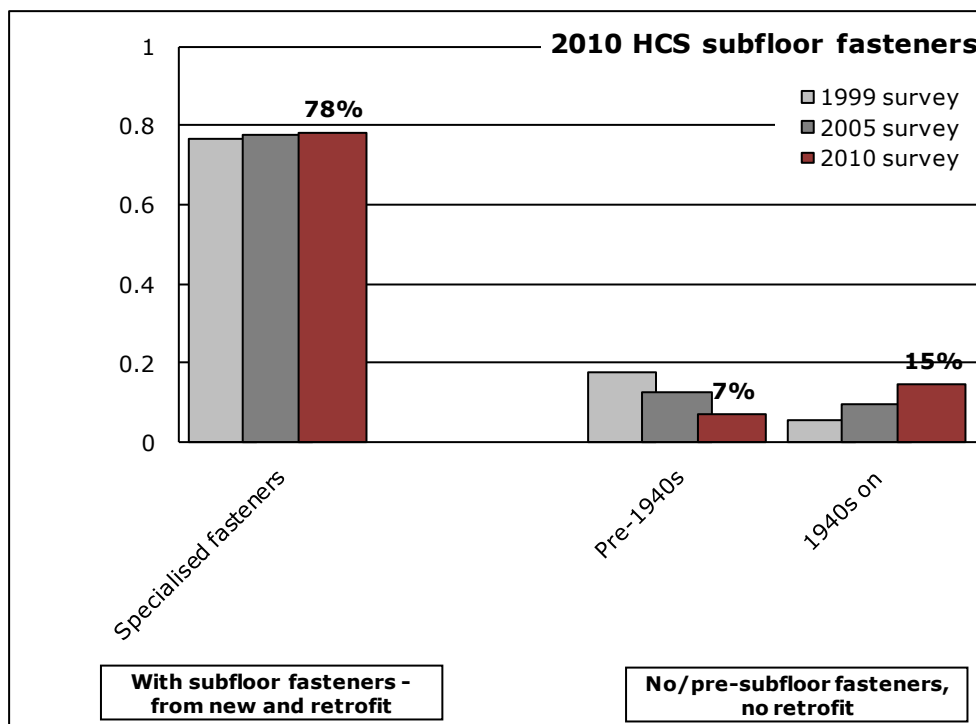
Figure 22: Subfloor fasteners

As seen in Figure 22, nearly one quarter of the houses in the 2010 *House Condition Survey* had no specialised fasteners in their subfloors in line with findings from previous surveys. Houses built before the 1940s were made before specialised fasteners were commonplace. Seven percent of the sample falls into this category and still do not have any or have inadequate subfloor fasteners. However, 15% of the sample was built after the 1940 and do not have specialised fasteners. The breakdown of the sample without adequate subfloor fasteners is shown below in Figure 23.

Another common problem identified in the 1999 and 2005 surveys related to the lack of appropriate subfloor fasteners, with many houses having no specialised fasteners between concrete piles and framing timbers. These included more recent post-1940s houses, as well as older houses. Figure 22 gives the same analysis, comparing 2010 results with those from the past studies.

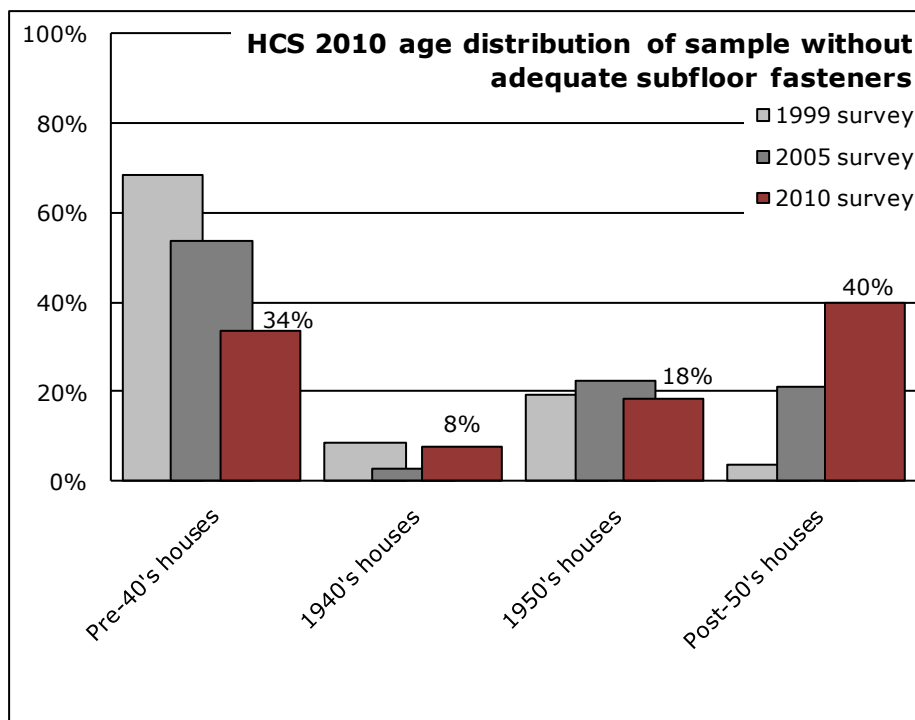
Figure 23: Age distribution of sample without adequate subfloor fasteners

Since the 1999 survey, the percentage of houses without specialised fasteners has fallen from nearly 70% being built pre-1940 to 34%. This could be the result of retrofitting of these subfloor areas, or conversely a larger number of modern homes being built without adequate subfloor fasteners.

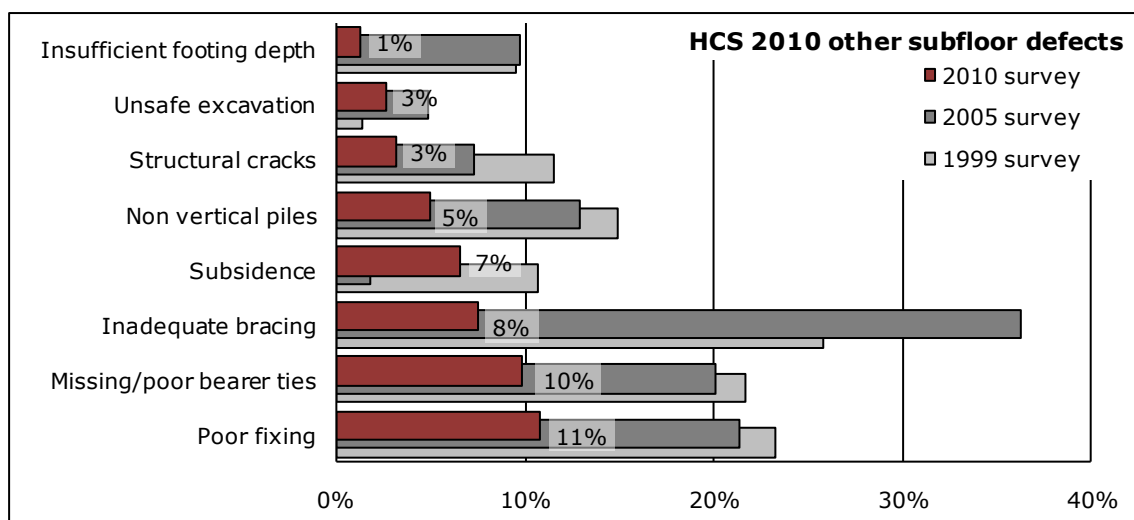
Figure 24: Other subfloor defects

Figure 24 gives non-moisture related defects found in subfloor areas, and compares these to both 2005 and 1999 survey defect findings. The percentages shown reflect the portion of accessible subfloors that exhibit the particular defect, which means that any particular subfloor may have more than one defect.

As previously noted, common structural defects found in the survey included poor fixings and lack of adequate bracing. However, the frequency of all defects had reduced when compared with previous surveys. In 2005 it was found that Auckland houses were more likely to have inadequate bracing than in the other cities that were surveyed (Clark, 2005). Therefore the inclusion of other areas (and comparative reduction in the percentage of the sample in Auckland) may have had an influence on the number of houses found with inadequate bracing.

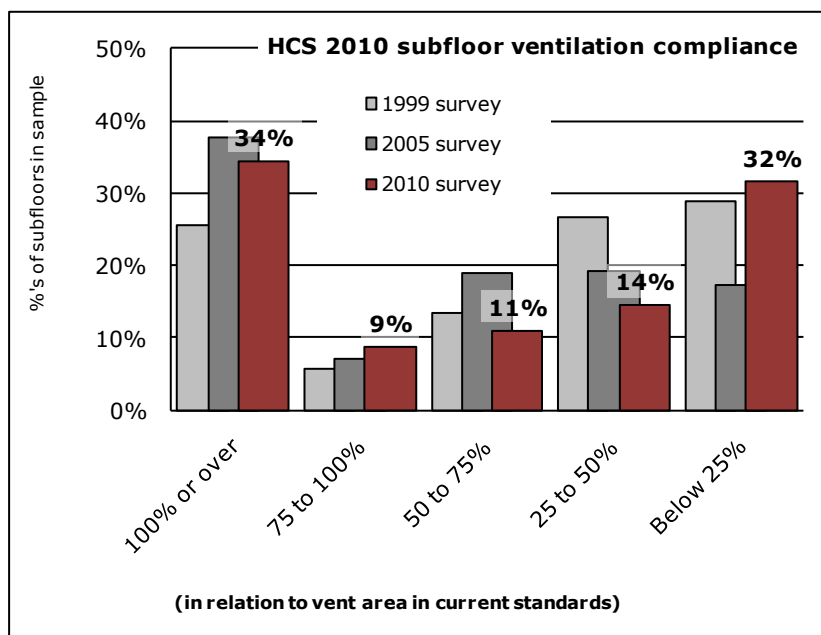
Figure 25: Percentage of current standard subfloor vent requirements

The results are broadly similar to those of previous surveys, with nearly two-thirds of the sample not meeting the current standards for a clear vented area and nearly one-third of the sample with less than one-quarter of the required clear vent area. The percentage of the sample with the least ventilation is around the same as what was found in 1999, and close to twice that of 2005.

In the past surveys, inadequate subfloor ventilation was identified as a common issue with suspended timber floors in the samples. The results from 2010 are shown alongside those of 2005, 1999 and 1994 in Figure 25.

More than 65% (2005: 62%, 1999:75%, 1994: 60%) of houses with timber-framed floors have poor or seriously deficient ventilation of subfloor spaces. As noted in the previous reports, it is surprising to find this level of serious inadequacy as the current Building Code requirement for ventilation has been in existence since the 1940s. It seems that few local authorities were using or enforcing these vent requirements. In addition to the inadequacy of constructed vents, owners themselves have often contributed to the problem by blocking vents.
