STUDY REPORT

SR 240 (2011)

Preliminary BRANZ 2010 House Condition Survey Report – Second Edition

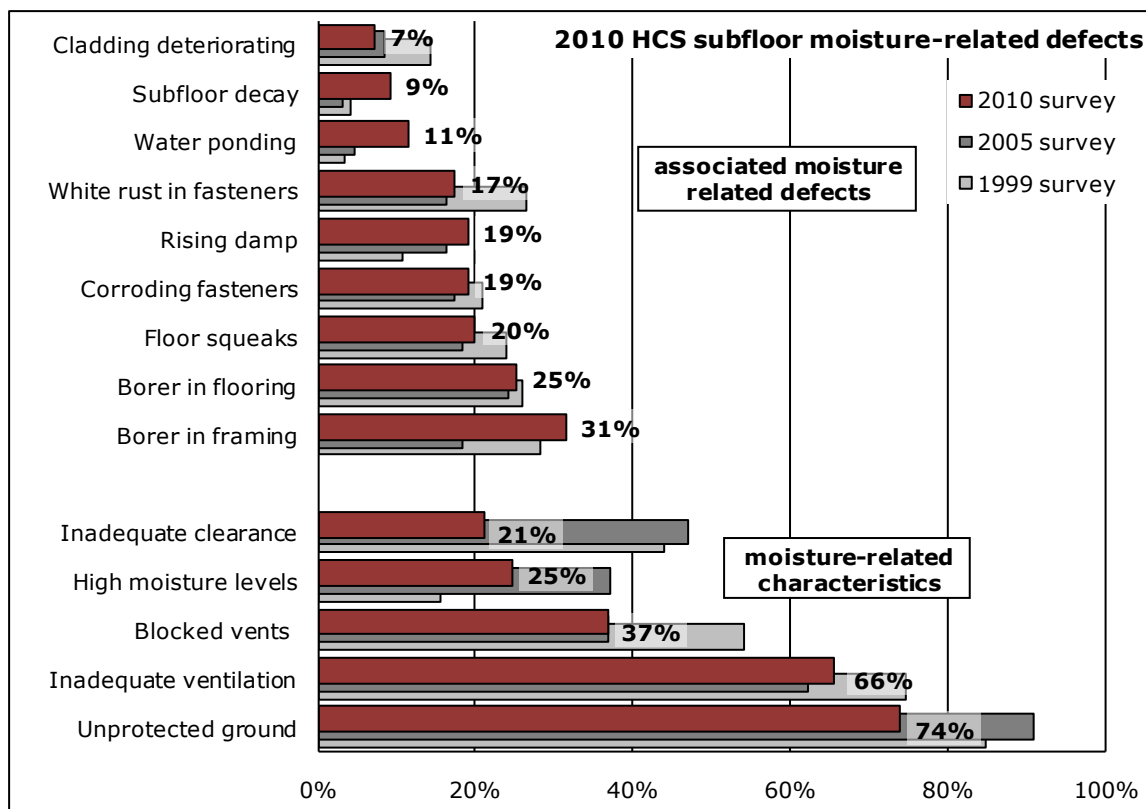
Figure 26: Moisture-related defects in subfloors

The results from 2010 are broadly similar to those of 2005 and 1999. Moisture-related characteristics are higher than the proportion of moisture-related defects, illustrating that there is not a direct correlation. However, there is an influence with increased likelihood of the defects occurring over time if the situation is not remedied.

- borer in framing was observed in more suspended timber subfloors in 2010 than in 2005, but were similar in frequency to 1999.
- there was a reduction in the percentage of suspended timber floor houses with high (>18%) moisture content between 2005 and 2010, although it remains slightly higher than those found in 1999
- there was less inadequate clearance between framing and the ground than what was found in 2005 or 1999

Figure 26 displays the prevalence of moisture-related characteristics amongst the relevant sample with accessible subfloors alongside moisture-related defects.

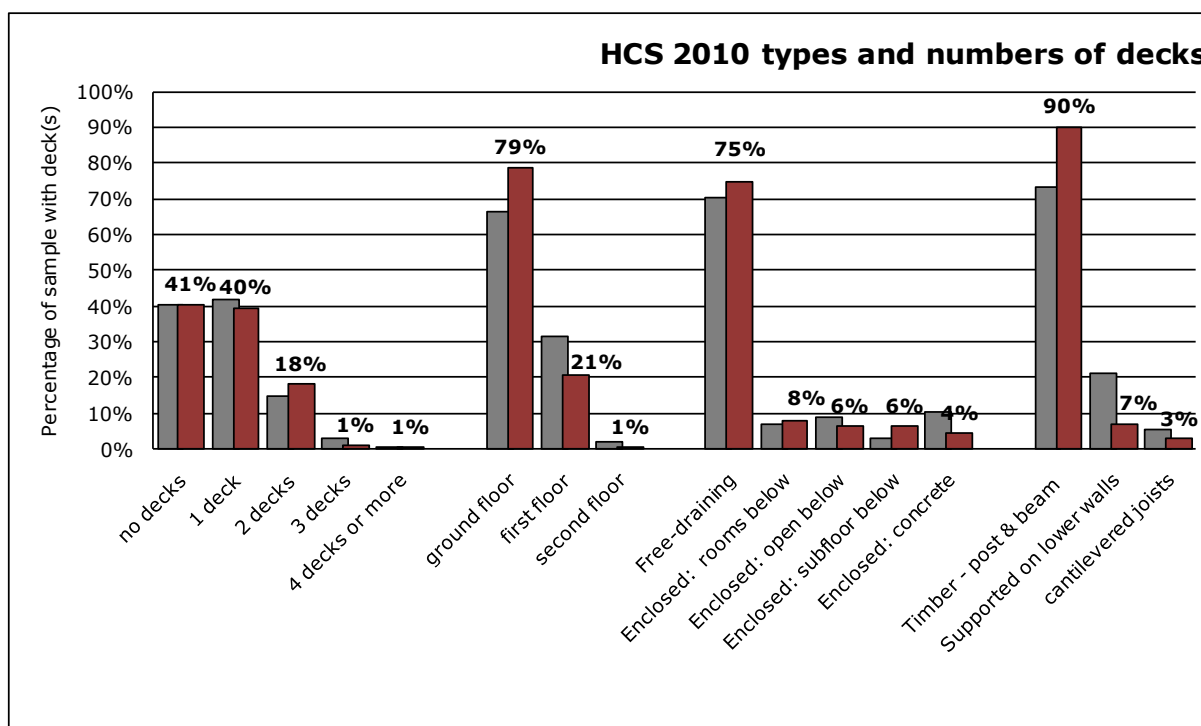
Figure 27: Types and numbers of attached decks

Figure 27 shows the following characteristics for attached decks:

Since 2005, the *House Condition Survey* has inspected and recorded details on decks attached to the houses in the samples. The numbers, types and characteristics of these decks are shown in Figure 27 for both 2005 and 2010.

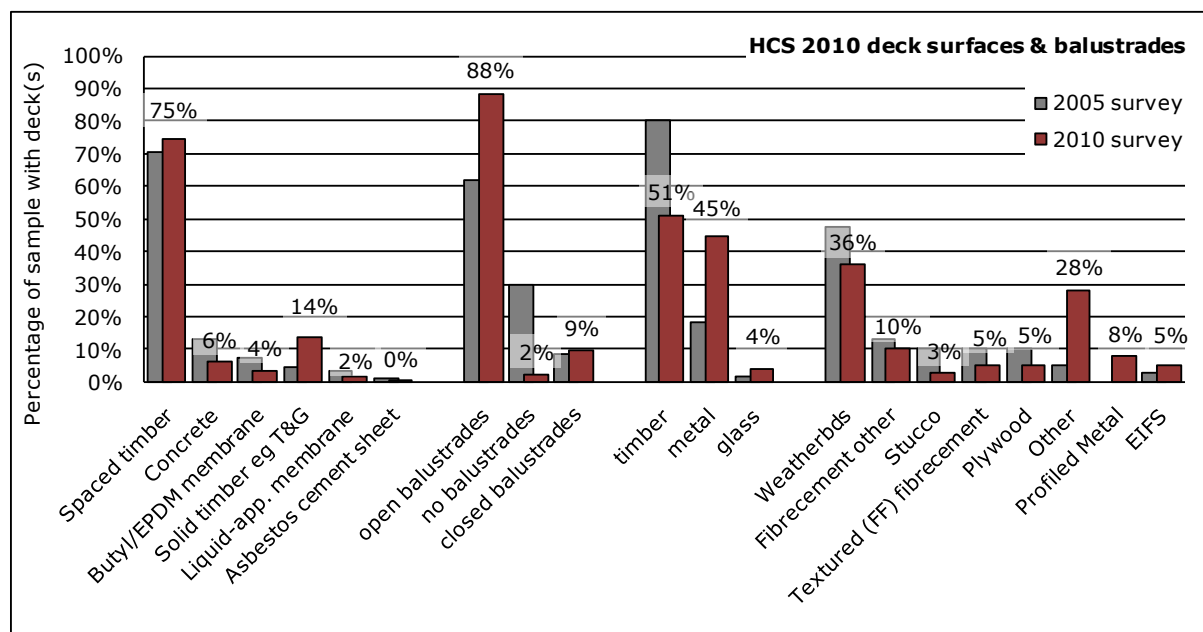
Figure 28: Deck surfaces and balustrades

Eighty-eight percent of decks over 1000 mm high had open balustrades (handrails with spaced rails or balusters), 2% had no balustrades and 9% had closed (solid) balustrades. Thirty-six percent of the closed balusters in the sample were timber, 28% were other (which includes glass), and 5% were clad with EIFS. Fourteen percent of balustrades were climbable types, such as horizontal rails.

The materials used for deck surfaces and balustrades in the 2010 sample are shown in Figure 28. As shown, three-quarters of decks had spaced timber slat flooring which matched the number of free-draining decks in Figure 27. Figure 28 shows the characteristics for deck barriers assessed in the sample.

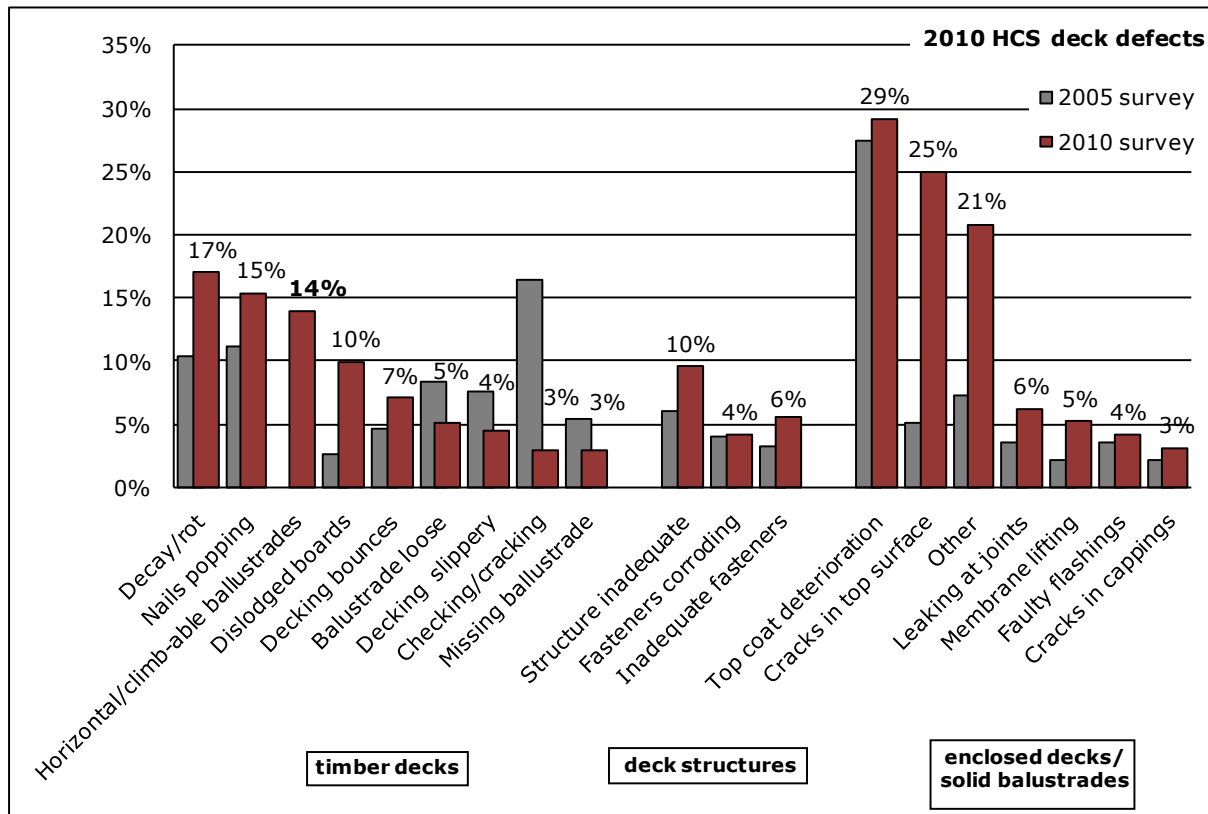
Figure 29: Defects in attached decks

The most common defects in timber spaced decks were decay, nails popping and dislodged boards. For enclosed decks, the most common defect affecting 29% of this type of deck was deterioration of the top-coat. This is mostly cosmetic, unless the paint is a moisture barrier. Ten percent of the deck structures were inadequate by today's standards, and 6% had inadequate fasteners.

14% of timber decks were non-compliant due to having either horizontal balustrades or rails which could be climbed (the data label highlighted in bold). The next section (6.4.3) looks at the compliance of the decks in the sample to current standards.

Defects found in decks are shown in Figure 29, and are separated into the structure and deck types.

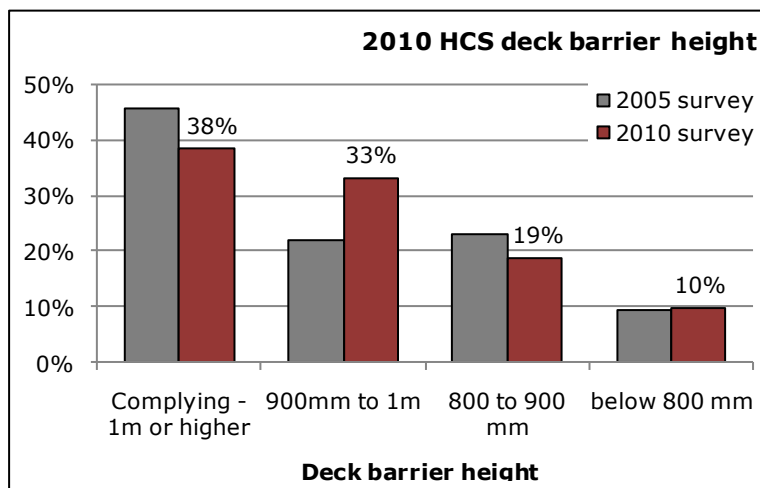
Figure 30: Deck barrier heights – 2010 and 2005

Deck barriers or balustrades were assessed for compliance with Clause F4 of the New Zealand Building Code (Building Code) (BIA 1992), and the results can be seen in Figure 30. The percentage of complying balustrades has fallen from 46% in 2005 to 38% in 2010, at least in part due to the larger number of post-1992 houses in the sample. The other 62% of barriers were non-compliant by modern standards due to either missing balustrades (either removed or never attached to decks above 1000 mm high), balustrades that were too low, openings that were too wide, or balustrades that could be climbed by small children (i.e. horizontal rails).

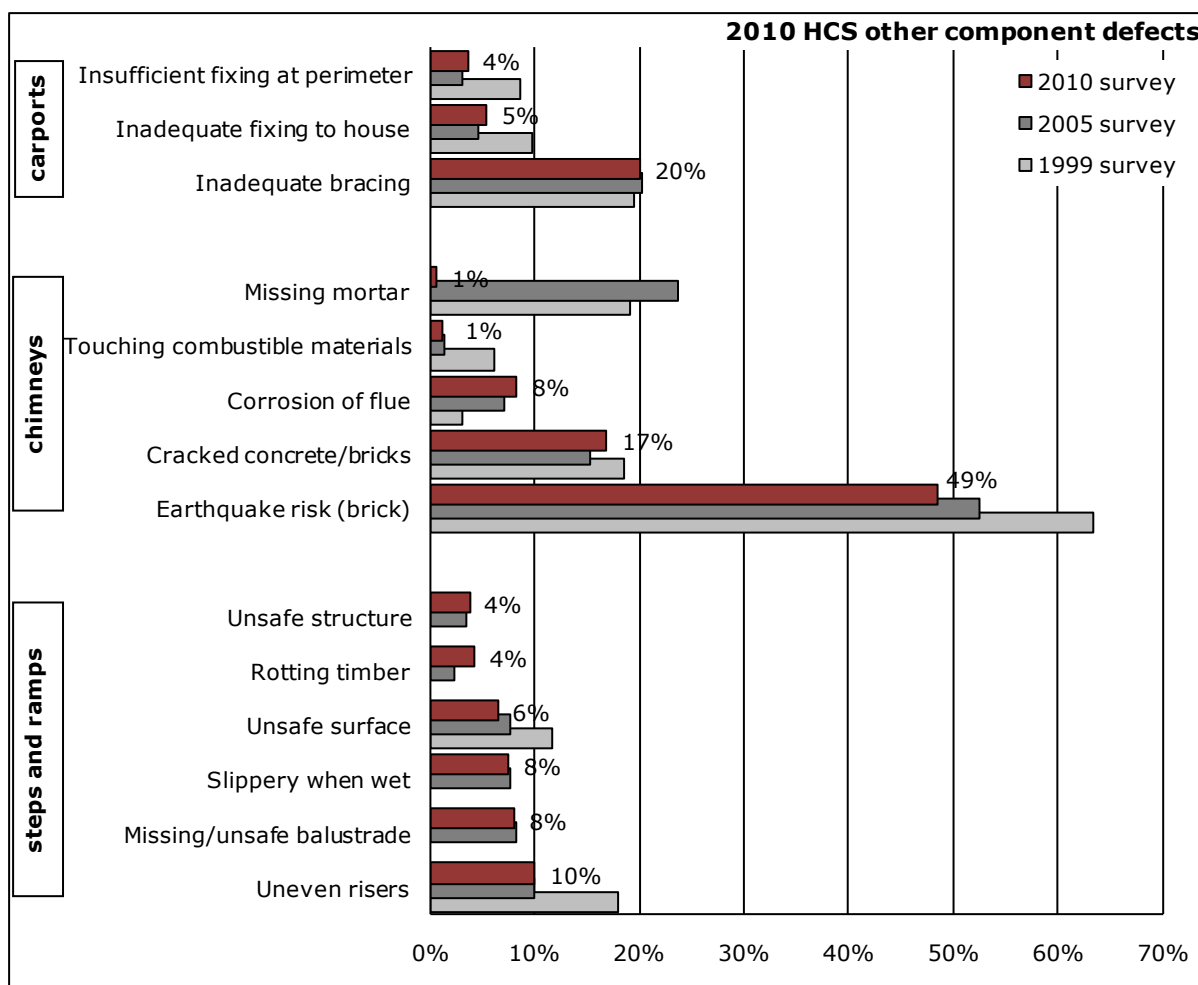
Figure 31: Defects in other components

As shown in Figure 31, defects are generally similar to those found in 2005. The main defect in carports remains the lack of adequate bracing. In common with past surveys, the most frequent defect in chimneys is generally associated with unreinforced brick chimneys in older houses. The decrease compared to past surveys reflects the increase in the number of newer houses in the sample, together with the removal of chimneys in a number of the older houses, rather than an improvement in chimney condition. The large decrease in missing mortar recorded in the 2010 survey is unexplained.

These chimneys were in line with building practices of the time (and are often still in good condition), they do not meet current earthquake standards, and are likely to be unsafe in a major earthquake. The incidence of cracked concrete or bricks in newer chimneys with cement-based mortars is also high (at 17%), providing a potential fire hazard if full-depth cracks are within the house envelope.

Figure 31 shows the common defects identified in carports, chimneys and steps or ramps.

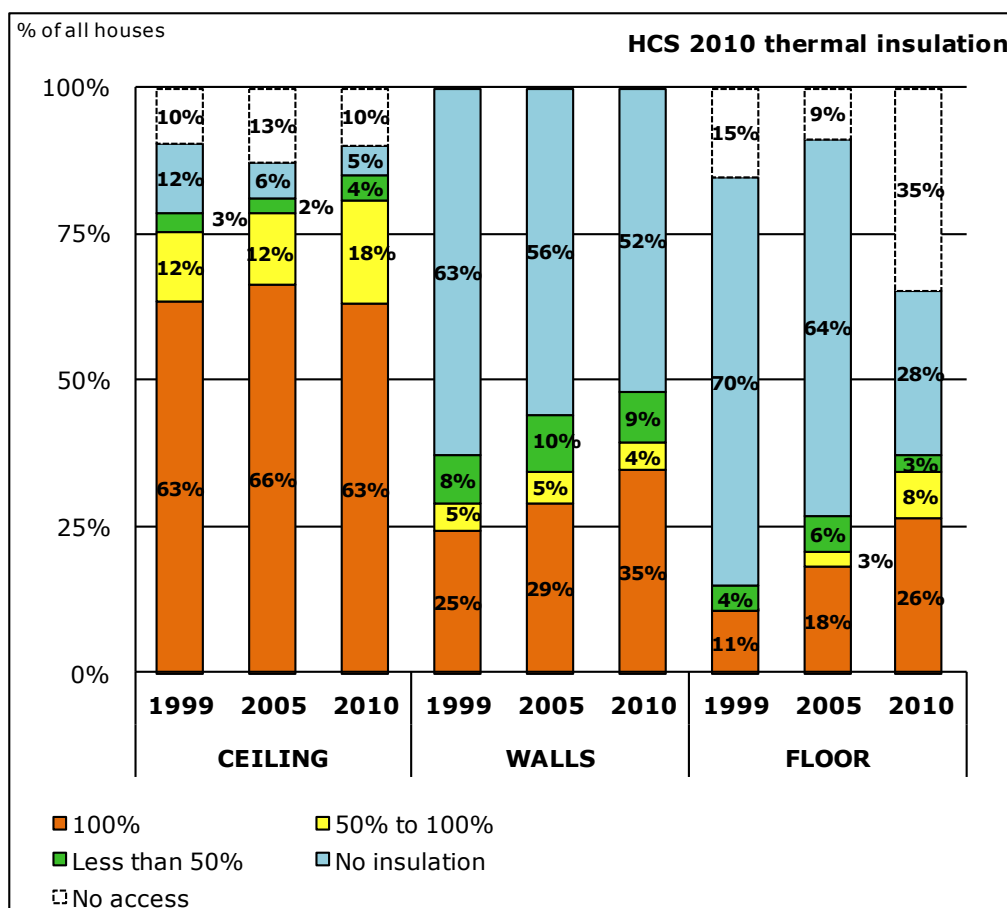
Figure 32: Presence of insulation

Wall insulation figures are based to a large degree on common sense assessments. In line with previous surveys, where a house was built before 1979 and the occupants did not know if the walls were insulated, the walls are assumed to be un-insulated.

A higher percentage of homes in the 2010 survey had at least some insulation than in any of the previous surveys, as seen in Figure 32. There were a higher percentage of insulated suspended floors (37% of all suspended floors, up from 27% in 2005). Ignoring the inaccessible suspended floors, this figure increases to 57%.

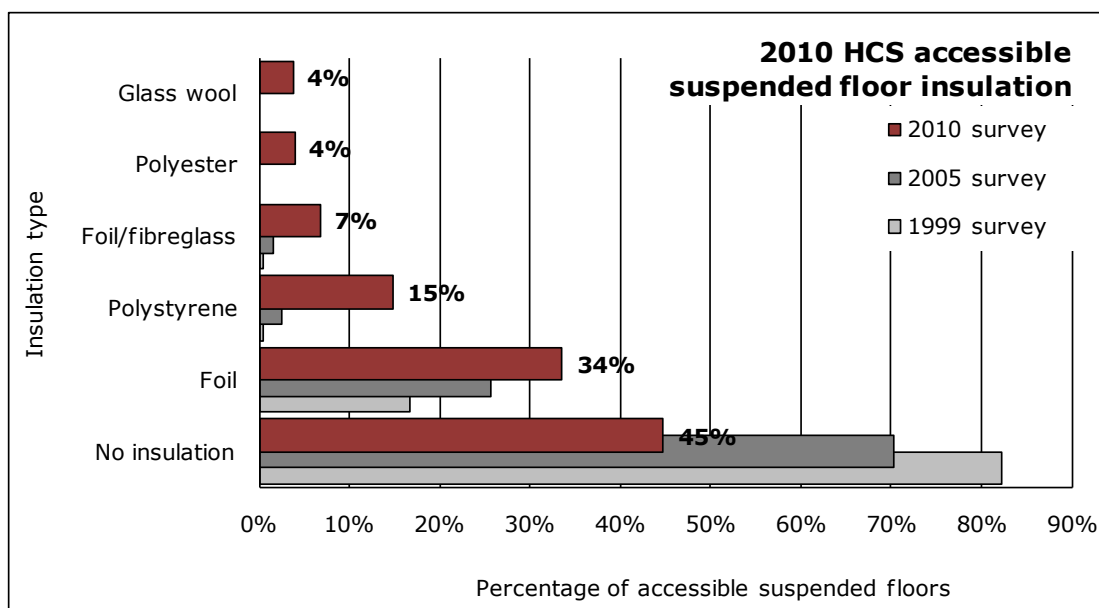
Figure 33: Insulation of suspended floors

Although the surveys indicate continuing increases in floor insulation over time, 45% of accessible suspended floors (in houses of any age) remain uninsulated, despite some form of underfloor insulation being required since insulation standards were introduced in 1978. Although more houses are being built, a large percentage of predominantly pre-1978 homes still have uninsulated floors, despite being a target of recent insulation subsidy schemes. However, there is likely to be polarisation between rentals and owner-occupied houses in regard to the presence of insulation, which will be further explored in later work.

The percentage of insulated accessible suspended floors has risen between 1999 and 2010, as seen in Figure 33.

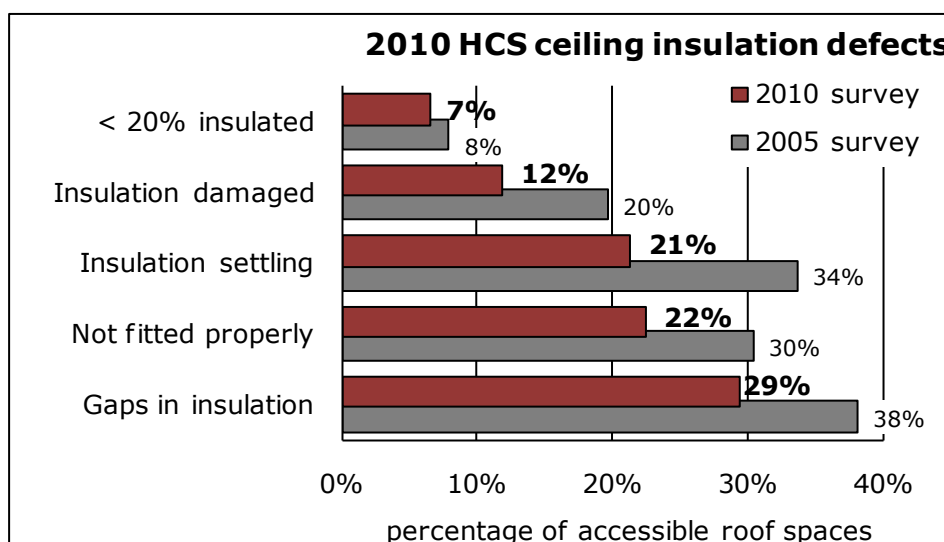
Figure 34: Defects in ceiling insulation

Although defects appear to be decreasing since the last survey, the prevalence of ceiling insulation issues is still notable. Twenty-nine percent of homes with accessible roof spaces had gaps in insulation, 22% had poorly fitted insulation, and 21% had insulation settling

(making it less effective at preventing heat loss). Twelve percent of accessible roof spaces had damaged insulation, predominantly caused by tradespeople or occupants.

As seen in Figure 34, the percentage of homes with less than 20% ceiling insulation has remained around the same between 2005 and 2010, despite the aforementioned insulation subsidy schemes. The incorporation of rentals may be a prime cause of the lack of movement in this figure.

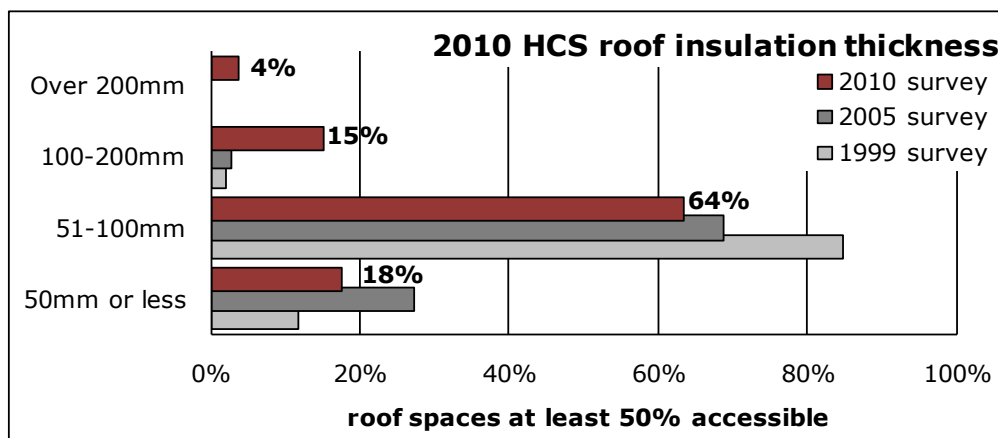
Figure 35: Thickness of existing roof insulation

There appears to be an upwards trend in insulation thickness. As seen in Figure 35, 3% of the sample in 2005 had insulation between 100 and 200mm thick, compared to 19% over 100mm thick in 2010. Four percent of ceiling insulation in 2010 was over 200mm thick.

With increasing awareness of the benefits of insulation, and the recent schemes set up to insulate existing homes, the bands of insulation thickness were increased from what was used in previous surveys to allow the infiltration of thicker insulation to be examined.

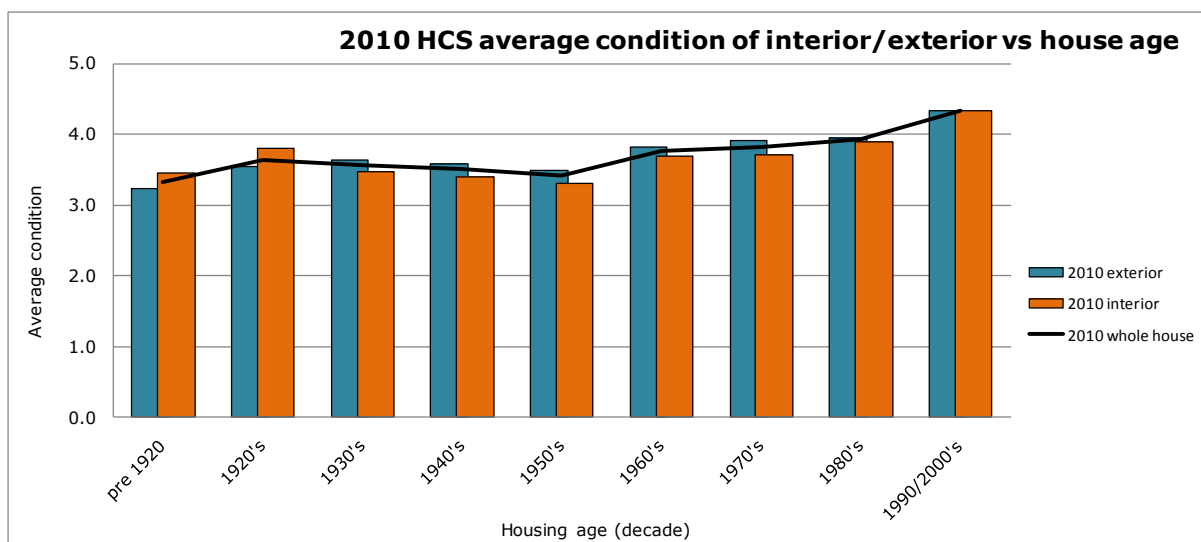
Figure 36: Interior versus exterior average condition by age of house

As seen in Figure 37, the condition of both the exterior and interior of houses is likely to be higher the newer the house. The condition of the interior is predominantly higher for houses built before 1920, however this trend reversed for houses built between the 1930s and 2010. This is in contrast to previous surveys, although the disparity between inside and outside condition had notably decreased between 1999 and 2005 surveys. This may indicate a trend of increased emphasis on the exterior condition of houses.

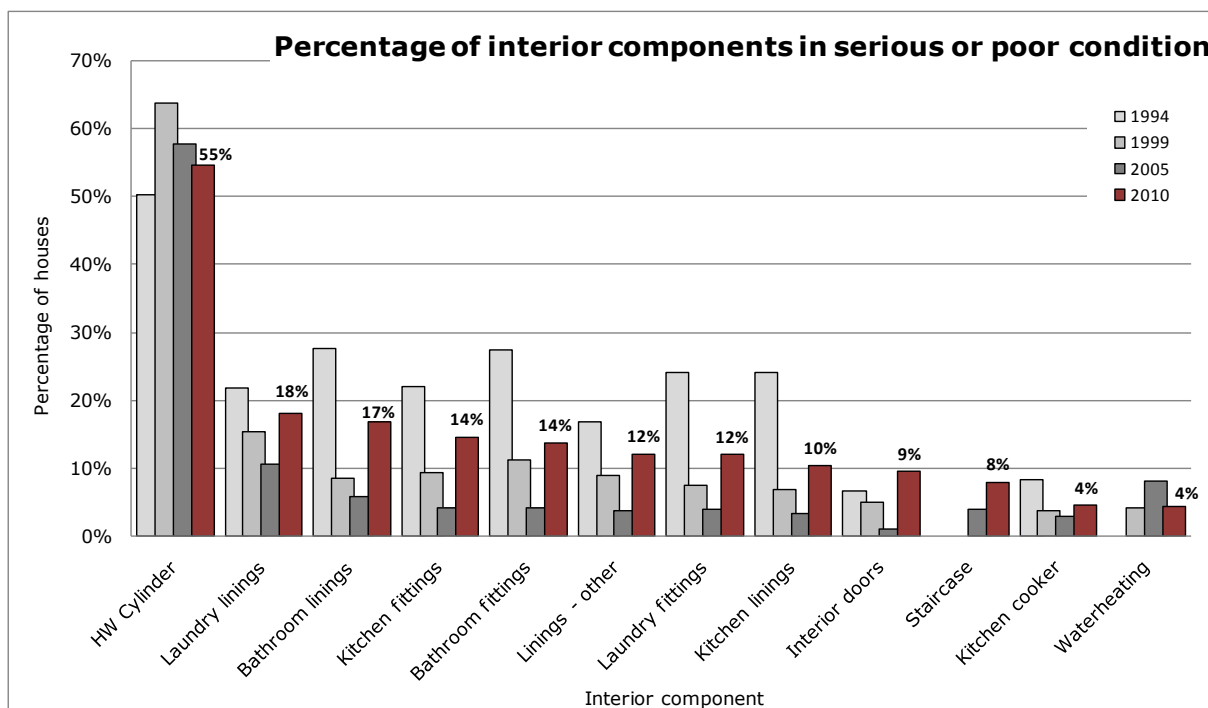
Figure 37: Percentage of interior components in serious or poor condition

Of all interior components, hot water cylinders are the most likely to be in poor or serious condition, at 55% of all hot water cylinders in 2010. A key reason for this is the number of cylinders without seismic restraints (50%).

Laundry, bathroom and other linings were in poor to serious condition in between 12% and 18% of houses. This may be due to mould, holes or missing linings, all a risk to occupant health and safety.

Plumbing fittings also rated quite highly among the components in poor to serious condition, which may indicate broken or missing fittings, damage or malfunctioning fittings. This potentially compromises the sanitation of the affected homes.

As shown in Figure 37, there percentage of interior components found to be in poor or serious condition was higher than in 2005, although in most not as high as in 1999. This increase may reflect the inclusion of rentals in the 2010 survey sample.

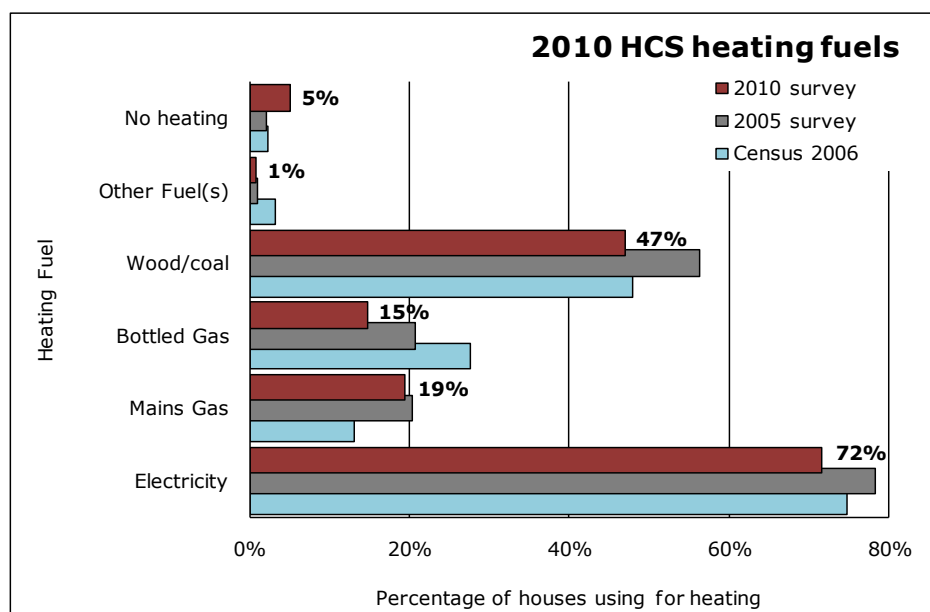
Figure 38: Heating fuels used

The most common heating fuel in New Zealand is electricity, with 72% of the *House Condition Survey* houses using this for space heating (Figure 38). Wood/coal followed at 47%. However, this does not necessarily mean that the bulk of heat produced comes from electricity. The Household Energy End-use Project (HEEP) found that more than half of New Zealand's residential heating was done with solid fuel (wood or coal)⁵.

Seventy-two percent of the sample used electric heating types, followed by wood or coal at 47%.

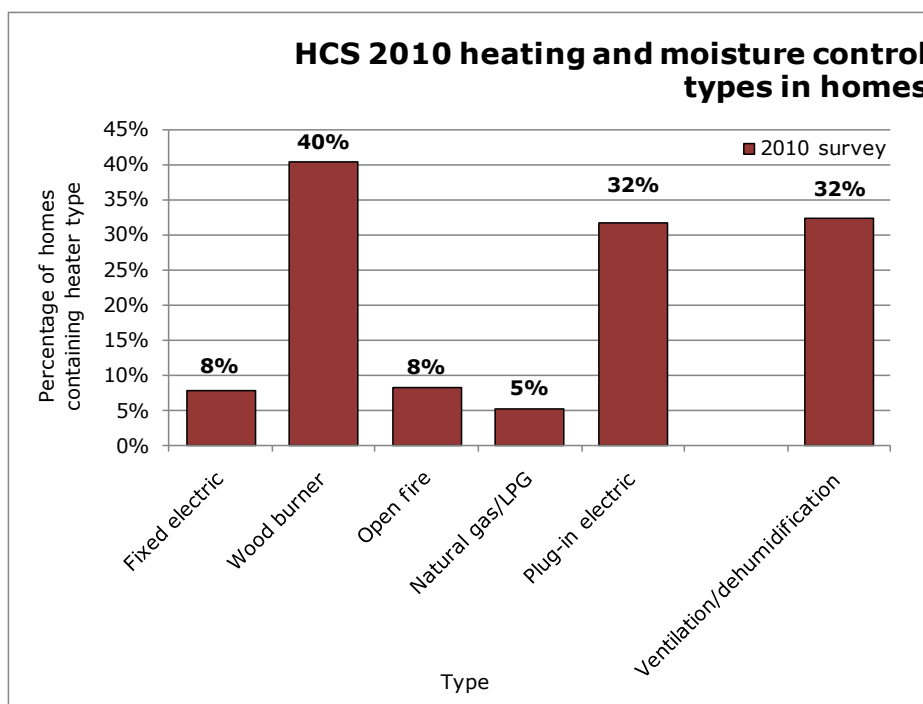
Figure 39: Heater and active moisture control types found

The most common type of heater found in the survey was plug-in electric heaters. This graph provides a view of the infiltration of the heating types into New Zealand homes as opposed to the most used, highest energy consuming, or highest heat output heating types.

Thirty-two percent of homes had either a dehumidifier or a forced air ventilation system (often roof space-sourced with ducted ceiling outlets).

New Zealand's houses deploy a range of predominantly localised forms of heating in cooler parts of the year. The percentage of the sample with each form of heating is shown below in Figure 39, along with moisture control measures.

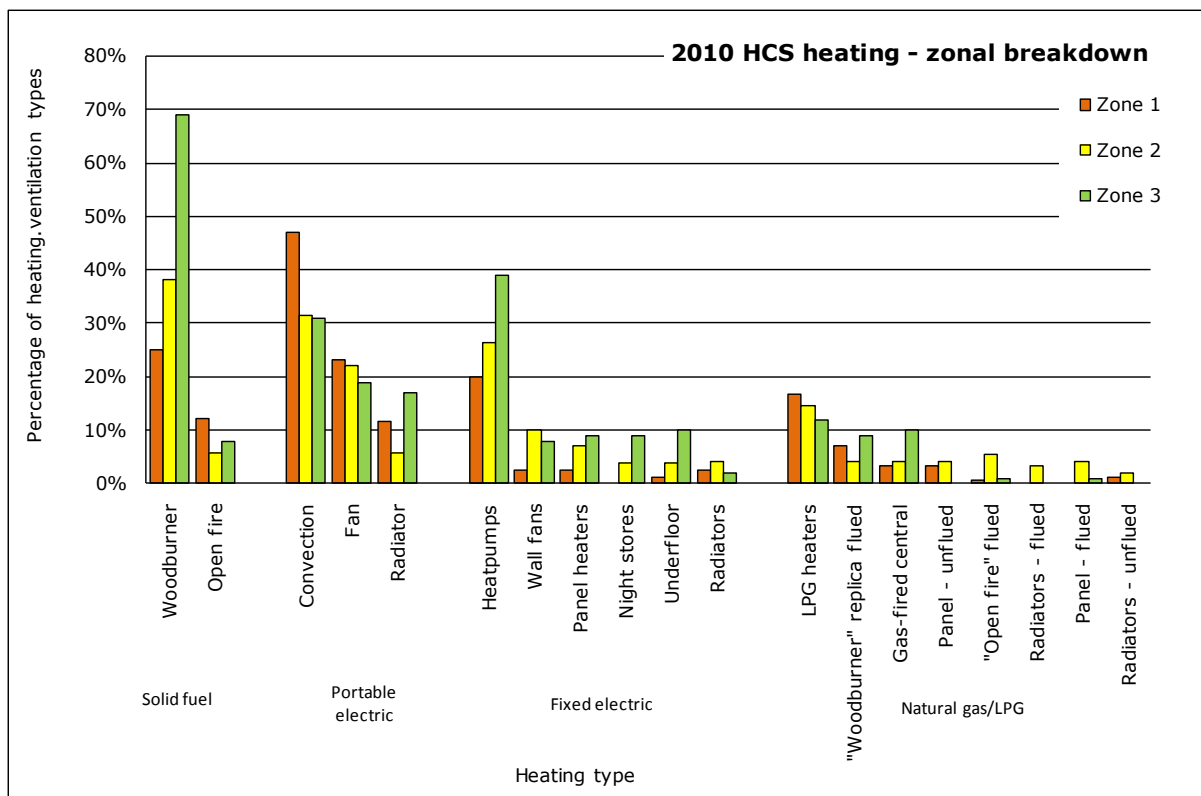
Figure 40: Heating systems by zone

The most common heater types vary by location. Solid fuel burners and portable electric heaters are the most prevalent across all zones. Woodburners are the most common single type of heater in households in both Zone 2 and 3.

When broken down into these zones, there are clear differences in the distribution of heater types, as shown below in Figure 40.

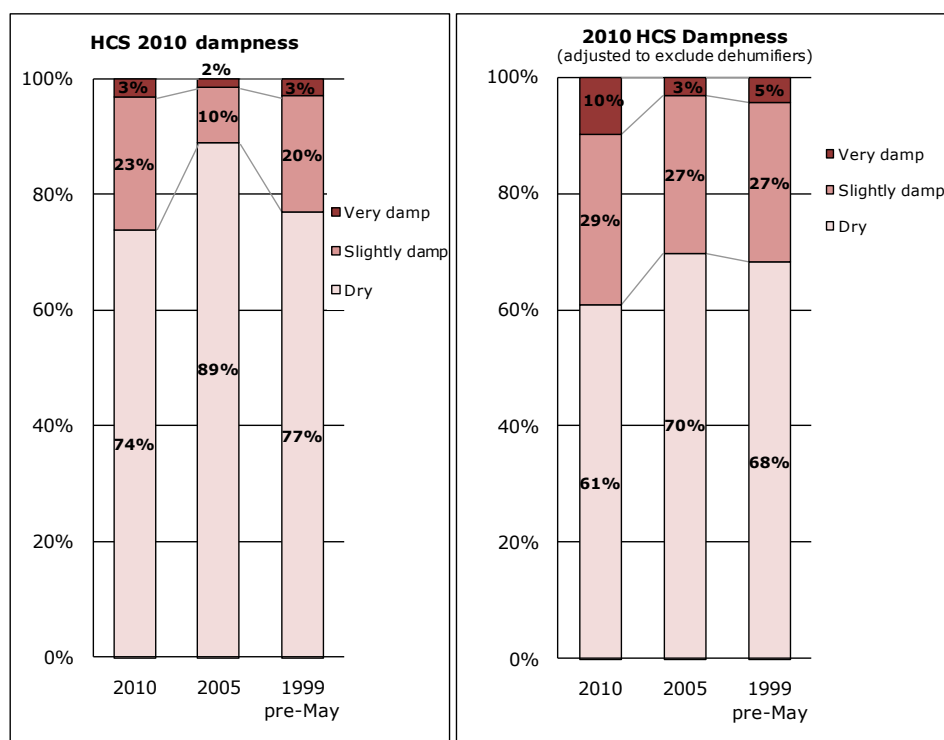
Figure 41: Subjective dampness assessments

Figure 41 shows the subjective dampness assessments from 2010 back to 1999⁶. Without taking into account dehumidifier use, over one quarter of the homes in 2010 exhibited at least some degree of dampness to the surveyors. To exclude the effect of dehumidifiers, an adjustment to push houses up the scale of dampness by one point out of five, the number of houses exhibiting dampness rose to nearly one in four houses (39%).

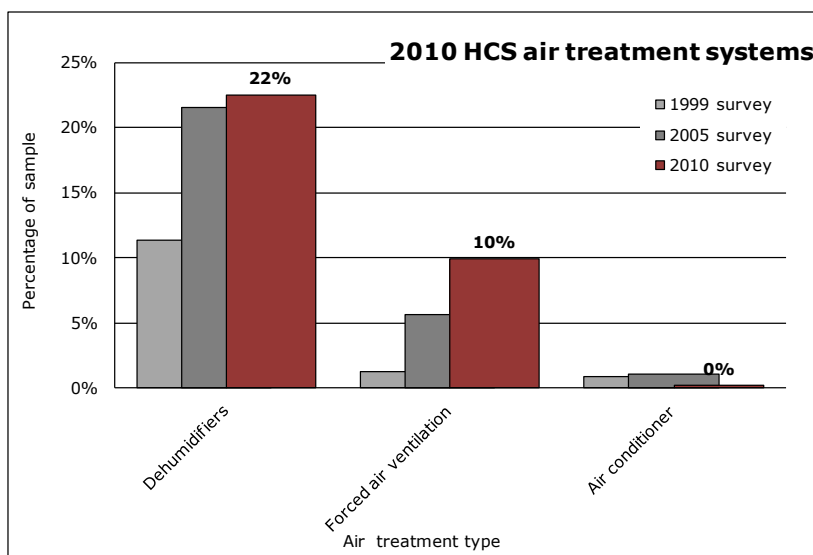
Figure 42: Air treatment types

A large area of growth has been the infiltration of forced air ventilation into New Zealand homes, with a percentage of homes with at least one system rising from 1% to 10%. This is likely to be due in part to the aggressive marketing campaigns that have been run over the past few years.

The use of technology to mitigate moisture issues within the home has been on the increase since 1999, as shown in Figure 42.

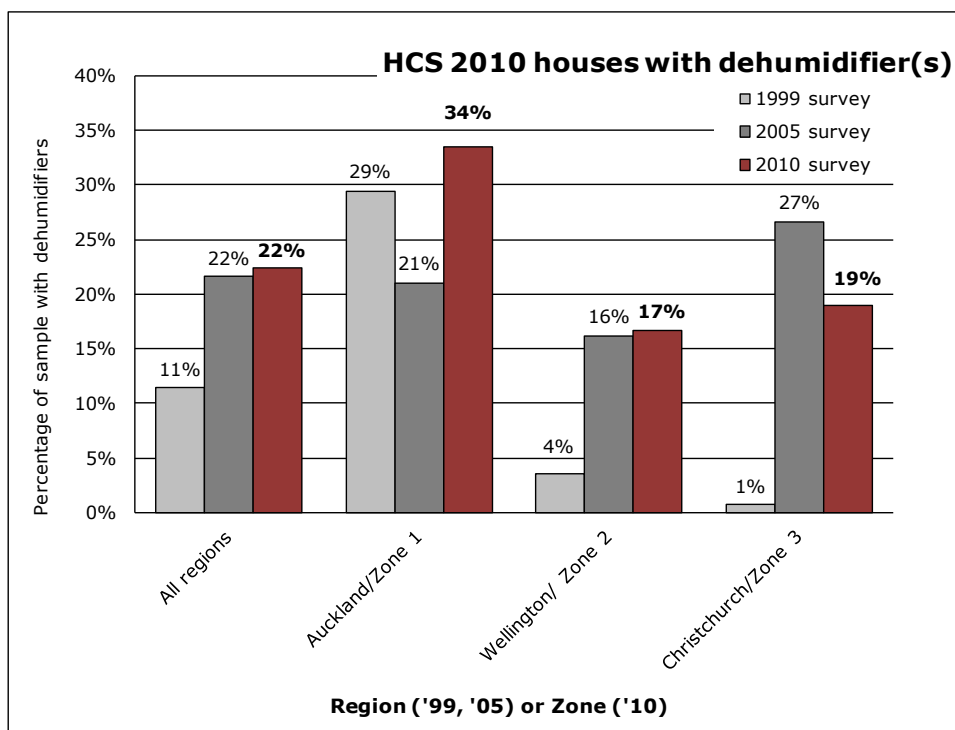
Figure 43: Dehumidifier prevalence by zone

In 2005, 21% of the Auckland sample had a dehumidifier; however this rose in 2010 to 34% of Zone 1 houses (which includes Auckland). The dehumidifier use remained about the same in Zone 2 (including Wellington), and decreased in Zone 3 (formerly including

Christchurch) since 2005. However the figures for Christchurch in 1999 and 2005 appear to be of a dubious nature due to an unexplained overall jump between 1999 and 2005. This may be in part due to the 2005 survey being conducted mainly in warmer seasons when dehumidifier use is expected to be lower, and appliance may therefore be in storage.

As can be seen in Figure 43, the percentage of the sample with dehumidifiers was 21%, about the same as in 2005. However, the distribution across the country appears to have changed.

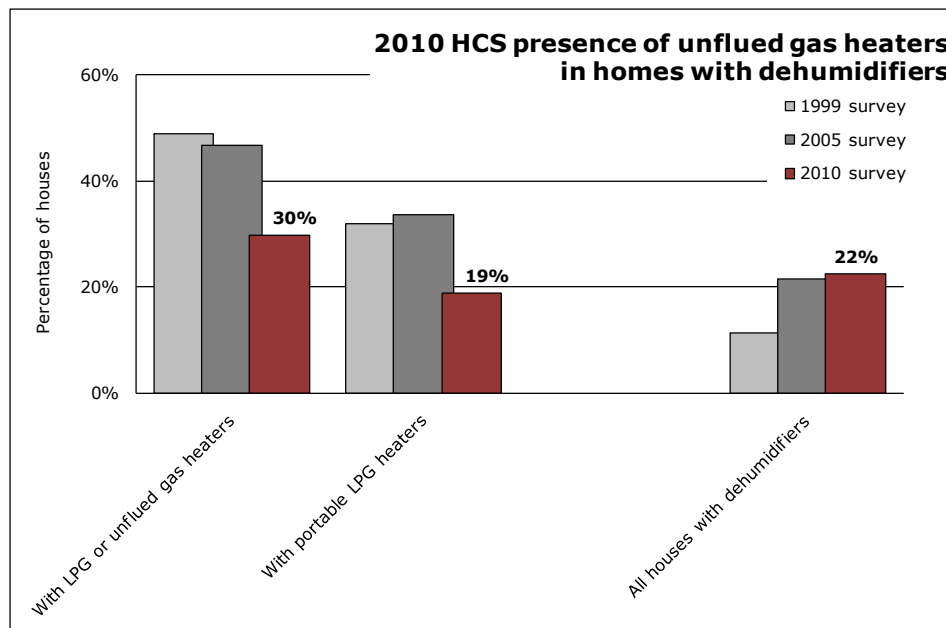
Figure 44: The relationship between the presence of dehumidifiers with unflued gas heating types

Unflued gas heaters, both natural gas and LPG, emit moisture as a by-product of combustion when they are operating. This leads to significant amounts of moisture being released into heated spaces, which may then travel into other parts of the house and be absorbed into the fabric of the building. Figure 44 shows the likelihood of dehumidifiers being present in surveyed homes with unflued gas heating types.

Houses with unflued (portable and fixed) natural or LPG gas heaters are more likely to have a dehumidifier, at nearly one third. Out of the entire sample, more than one house in five had a dehumidifier. Interestingly, homes with only portable LPG heaters were slightly less likely to have a dehumidifier, which on the surface contradicts what could be expected. However, the prepay nature of LPG heaters may lead to a higher presence in lower income homes where cost of purchase or operation of dehumidifiers may be prohibitive. Due to their portability, prepay nature and cost of operation, LPG heaters may also be used predominantly as supplementary or occasional usage. There may also be a relationship between the use of the heaters with location (climate and predominant heating types) and fuel availability.

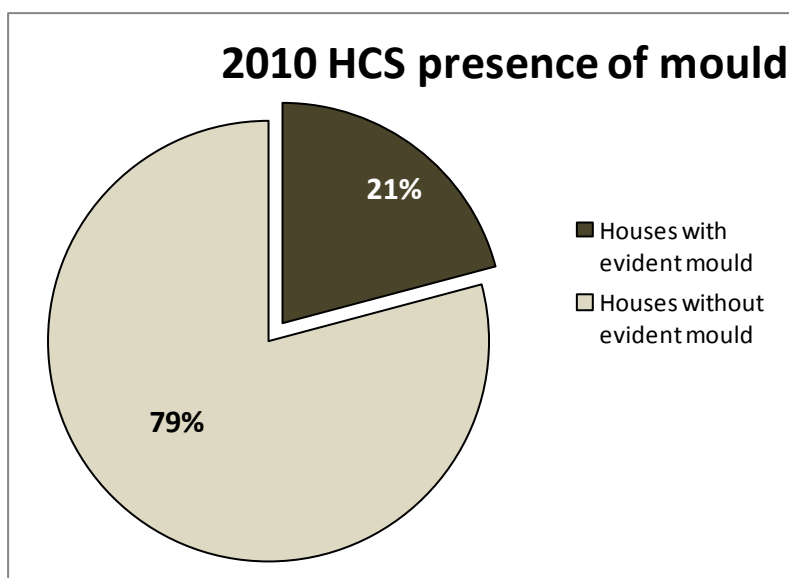
Figure 45: Mould evident during surveys

As seen in Figure 45, the 2010 *House Condition Survey* revealed that 21% of the houses had mould evident in at least one room at the time of inspection, ranging from specks to extensive coverage. This is likely to be a conservative figure, as householders may have “spring-cleaned” upon the making of an appointment for the physical inspection of the house.
